**SANTA SUSANA SITE WATERSHED 008 AND
009 BMP SUBAREA RANKING ANALYSIS**

August 2015

Santa Susana Field Laboratory

Surface Water Expert Panel

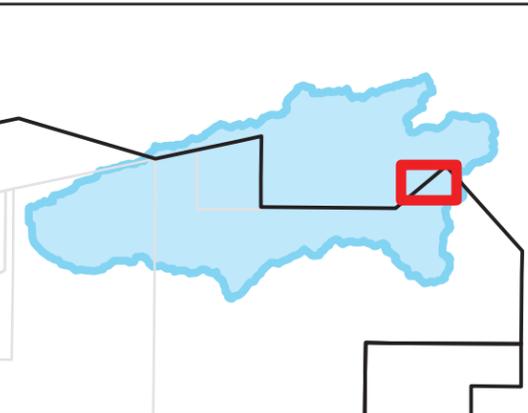
- Inspections were performed on this area as part of the ISRA SWPPP.
- Prior to each forecasted rain event, sandbags were placed at the curb cuts to help divert stormwater runoff towards the cuts (they were removed when it was not raining to prevent them from being run over and worn down).
- Accumulated vegetation and debris were also cleared away from behind the pretreatment check dams

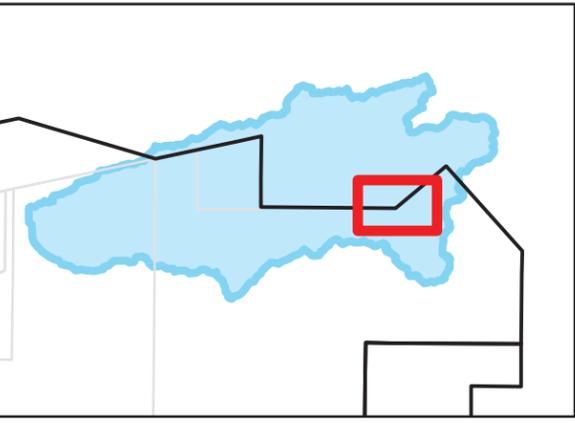
- Construction of detention bioswales was completed in December of 2014
- Hydraulic modeling of the low flow diversion, cistern, trench drain, and 24-inch storm drain outlet was conducted after the last wet season event of 2014/2015. A calibrated model has estimated approximately 40% capture at the low flow diversion since completion of the detention bioswales.

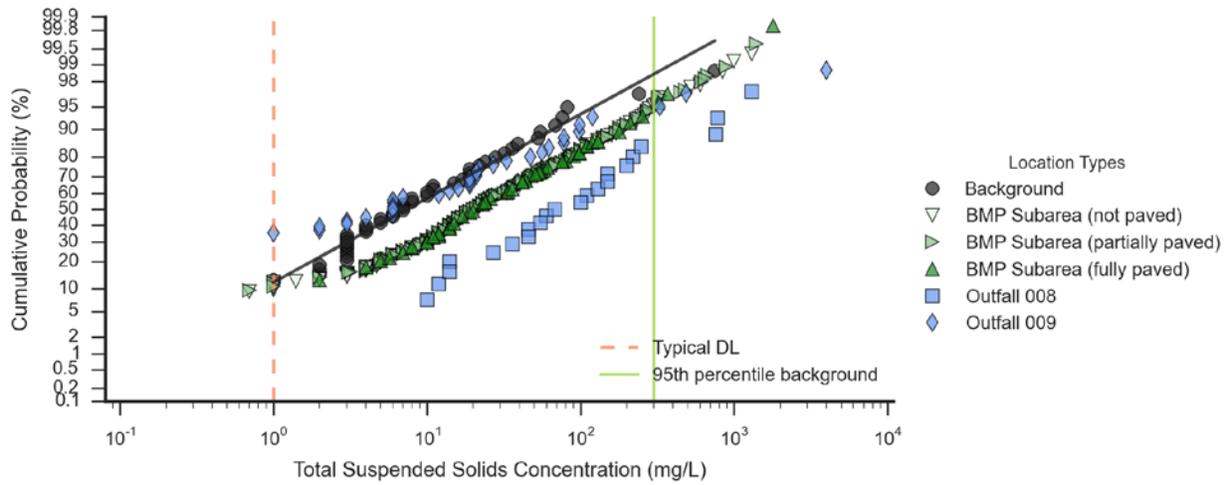
Figure 2. Probability plot for TSS concentrations¹⁸

¹⁸ Note: Following the 2005 wildfire, an uncharacteristically high TSS value (4000 mg/L) was measured at Outfall 009 on 10/17/2005. This data point is shown near the upper right corner of Figure 2.

- As shown in Figure 2, channel processes appear to be a significant source of TSS for Watershed 008 (based on observations from previous years) and less so for Watershed 009, where outfall TSS concentrations are near background. Northern Drainage improvements and stabilization measures are expected to continue providing a water quality benefit to these channels, particularly if the upcoming winter is wetter and helps channel vegetation to grow.

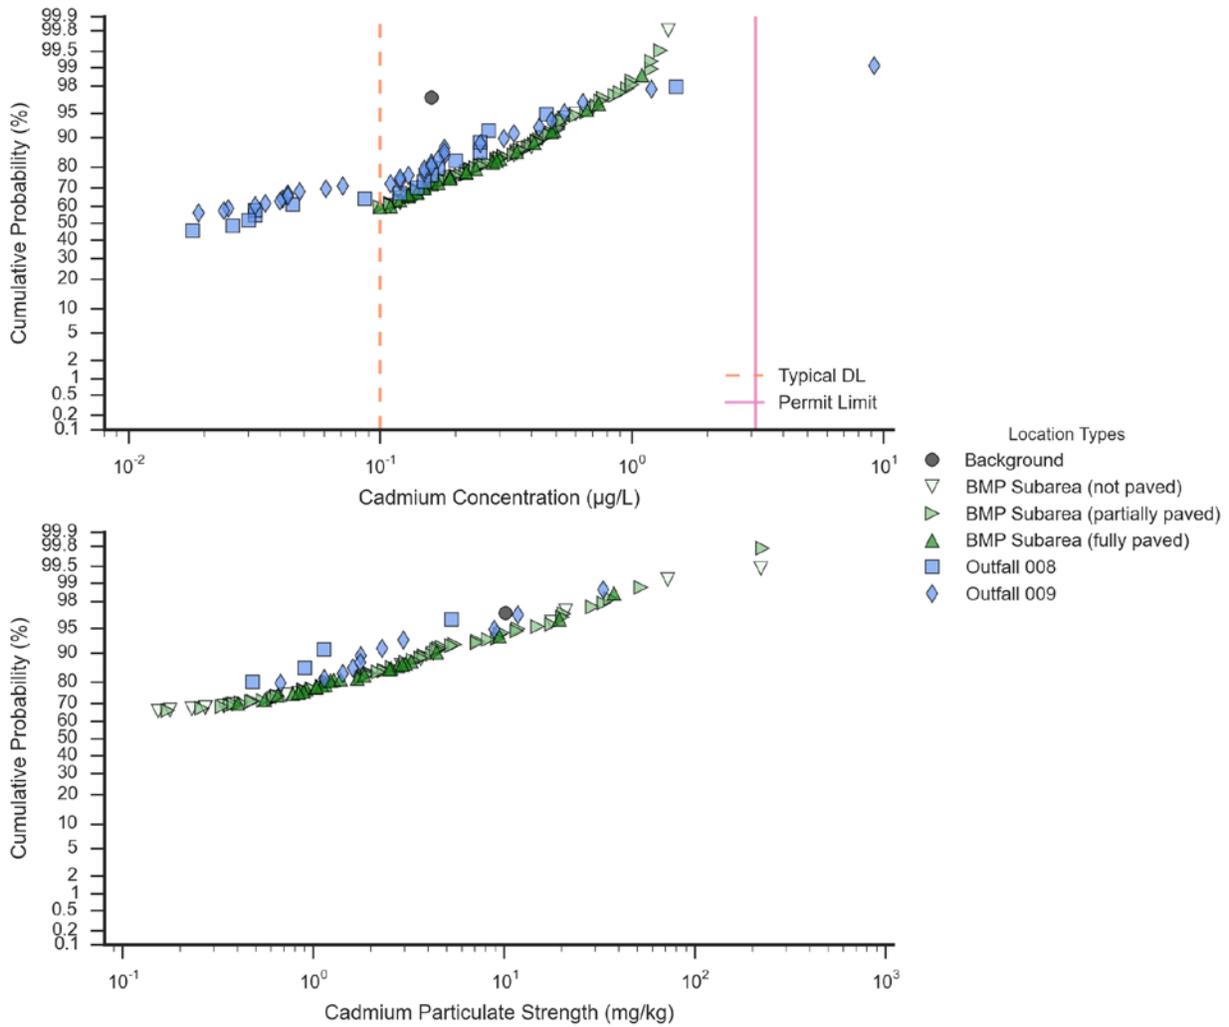
Figure 3. Probability plots for cadmium concentrations and particulate strengths^{19, 20}

¹⁹ Following the 2005 wildfires, an uncharacteristically high cadmium concentration (9.2 µg/L) was measured at Outfall 009 on 10/17/2005. This data point is shown in the upper right corner of the concentration plot in Figure 3.

²⁰ A background best-fit line was not provided for total cadmium due to the limited number of detected results.

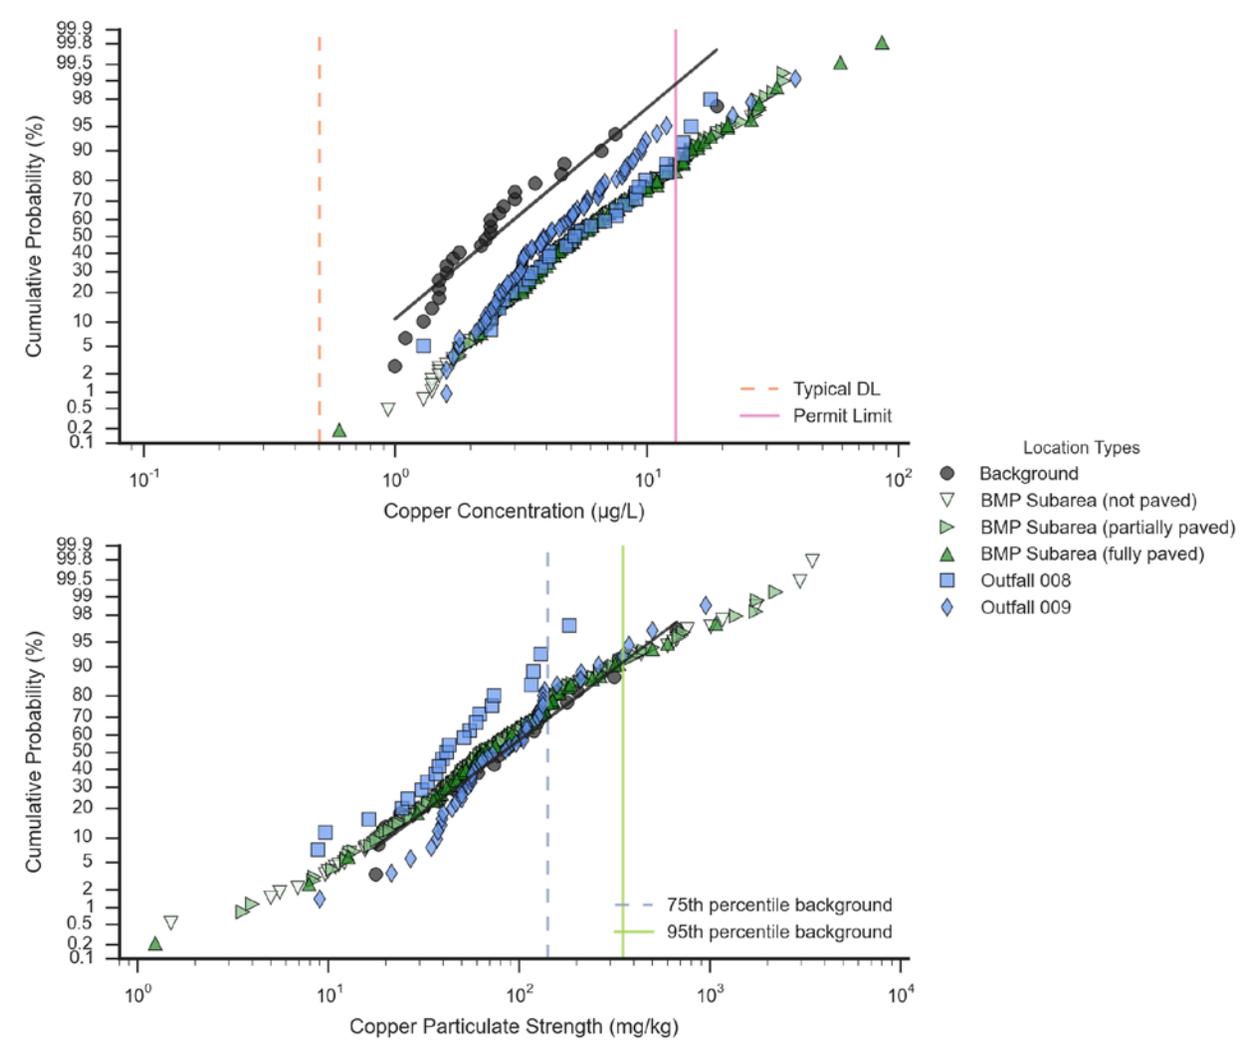
Figure 4. Probability plots for copper concentrations and particulate strengths²¹

²¹ Following the 2005 wildfires, an uncharacteristically high copper concentration (39 µg/L) was measured at Outfall 009 on 10/17/2005. This data point is shown near the upper right corner of the concentration plot in Figure 4.

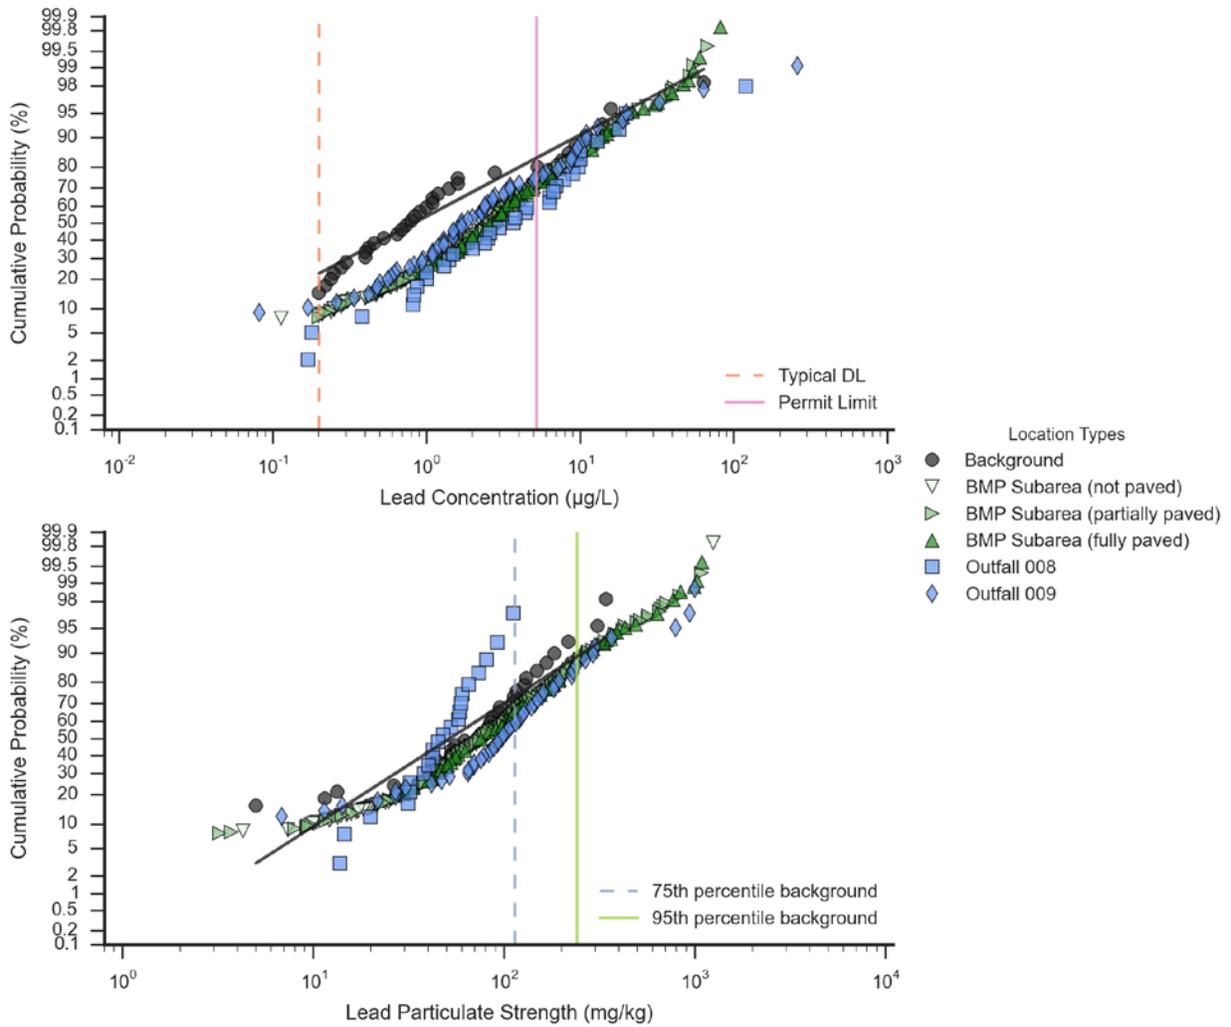
Figure 5. Probability plots for lead concentrations and particulate strengths²²

²² Following the 2005 wildfires, an uncharacteristically high lead concentration (260 µg/L) was measured at Outfall 009 on 10/17/2005. This data point is shown near the upper right corner of the concentration plot in Figure 5.

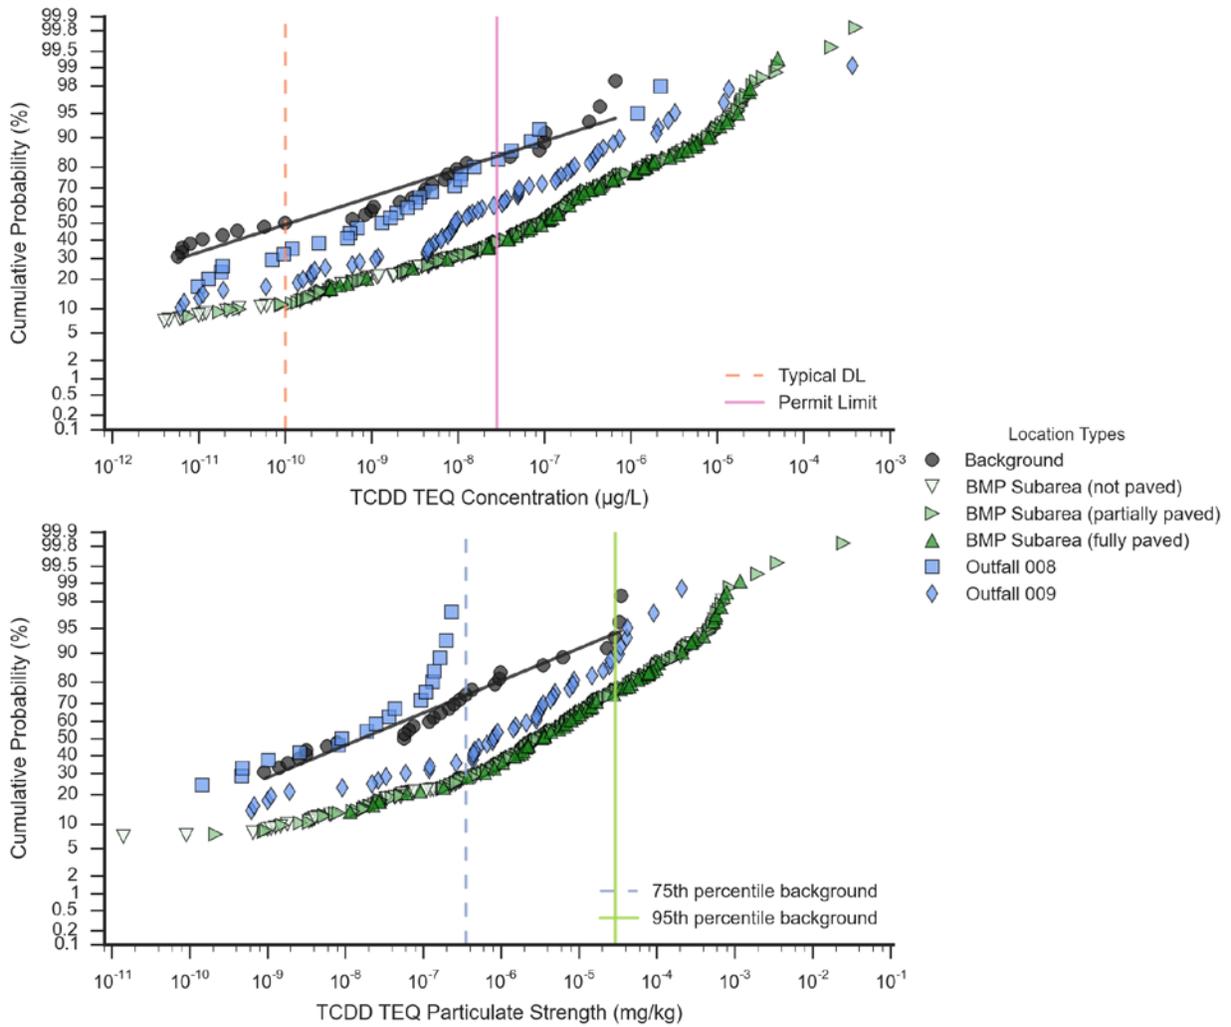
Figure 6. Probability plots for TCDD TEQ concentrations and particulate strengths²³

²³ Following the 2005 wildfires, an uncharacteristically high TCDD TEQ concentration (3.6×10^{-4} µg/L) was measured at Outfall 009 on 10/17/2005. This data point is shown in the upper right corner of the concentration plot in Figure 6.

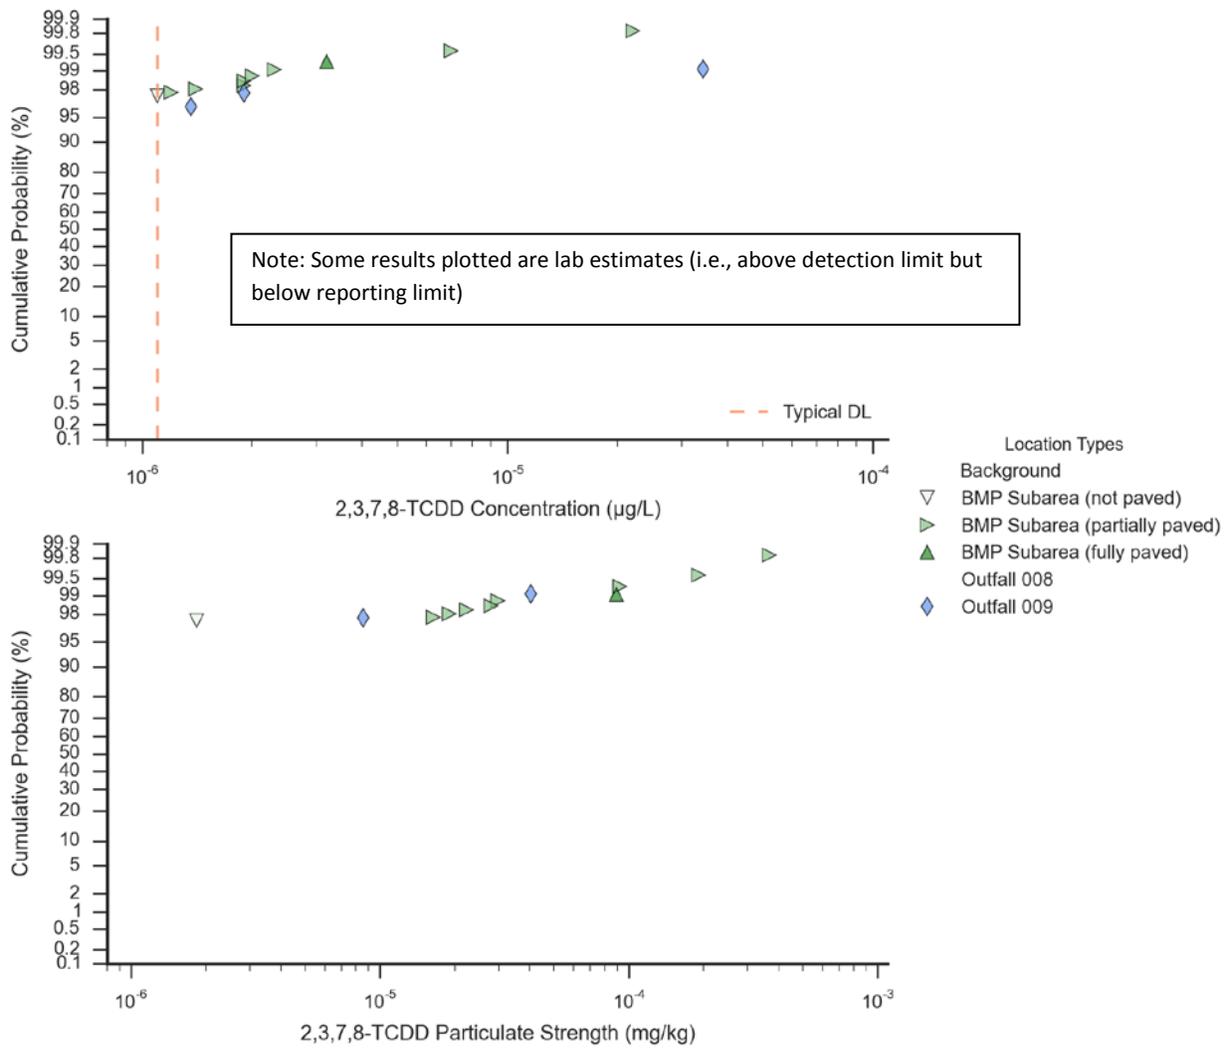
Figure 7. Probability plots for 2,3,7,8-TCDD concentrations and particulate strengths²⁴

²⁴ Following the 2005 wildfires, an uncharacteristically high 2,3,7,8-TCDD concentration ($3.4 \times 10^{-5} \mu\text{g/L}$) was measured at Outfall 009 on 10/17/2005. This data point is shown in the upper right corner of the concentration plot in Figure 7.
