Figure ES-3: CM-9 Area

Santa Susana Site
 Ventura County, CA

August 2014

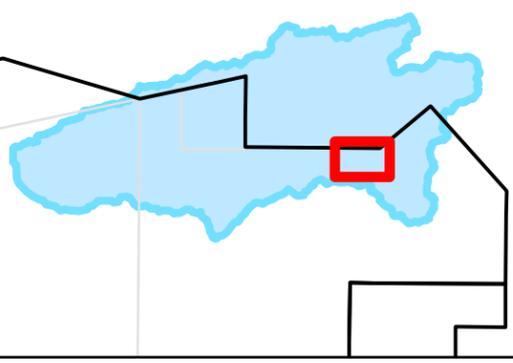
In March of 2013, improvements were made at CM-9 area including:

- Erosion control blanket and straw wattles were installed along the slopes adjacent to the Area II Road
- A low flow diversion inlet structure and a diversion pipe with perforations were installed to spread road runoff along the slope
- A rock berm was installed for ponding as pre-treatment to CM-9

In September of 2013, improvements included:

- Sediment removal at CM-9
- Mesh screen placed over culvert inlet to perforated pipe to prevent clogging.

Recommendations:

- Replace filter fabric on the CM-9 weir boards when the fabric becomes clogged or damaged
- Remove sediment accumulation at the inlet of the culvert modification and at the pretreatment rock berm
- Note any water ponded upstream of the weir board for greater than 72 hours as it may suggest that media or underdrain maintenance is needed
- Continue inspection and maintenance of BMPs

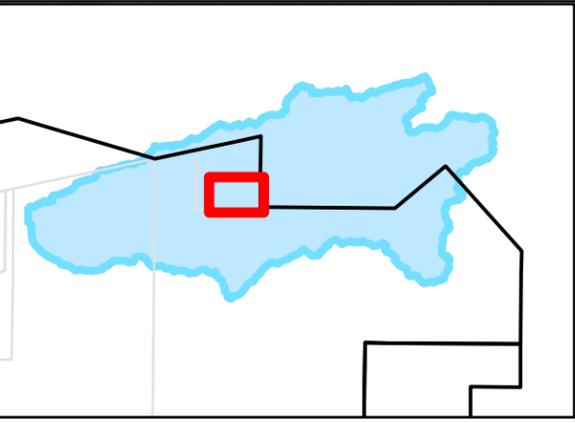
Figure ES-4: LOX Area

BMP Activities:

- Placement of jute matting on the south slope of the dirt road
- Installation of fiber rolls along the dirt road and slope to the south
- Fresh gravel applied along the dirt road
- Repairs to grade control structure on northern drainage channel at base of LOX
- Hydroseed applied to the slope

Recommendations:

- Continued inspection and maintenance of the LOX BMPs

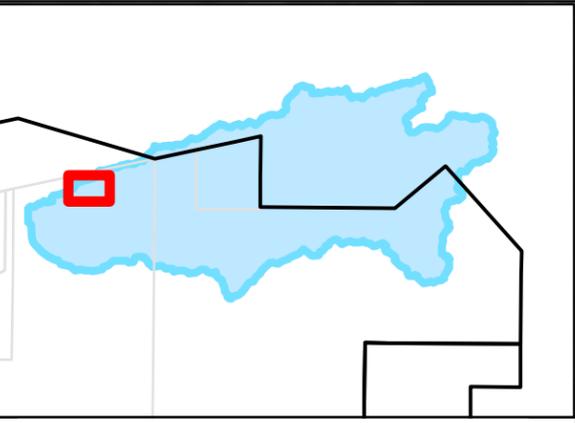
Figure ES-5: Helipad Area

EVBMP0002
Helipad runoff (OLD)
n = 6 (0)
Multi-Rank = 3

EVBMP0002-B
Helipad runoff, post improvements
n = 5 (1)
Multi-Rank = 39

Activities:

- In August of 2013 a concrete curb along the paved area west of the Helipad was constructed to route runoff from this area to the Helipad.
- Drainage from the west was modified by the installation of a lowered concrete slab, increasing flows from previous monitoring seasons.
- The sandbag berms and pumps were kept in operation during the 2013/2014 season.

Recommendations:

- Continued operation of temporary capture system or equivalent runoff capture and treatment as a temporary control strategy until NASA is able to remove asphalt from the Helipad area during the planned demolition.
- Ponded water should be pumped out to the sump area and the storm drain inlet "plug" under Helipad Road be removed when either 1) Outfall 009 is flowing or 2) the sump is overflowing onto Helipad Road.
- Continued inspection and maintenance of the Helipad sandbag berms and any future BMPs.

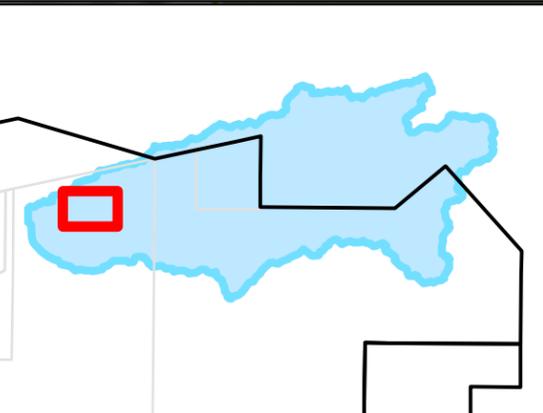
ELV stormwater treatment system was installed in November of 2013.
Sediment removal was performed at CM-1 in September of 2013.

- In March of 2014 following a site visit the Expert Panel submitted recommendations to NASA including:
- Improved erosion control along the earth-bottom portions of the ELV channel (completed)
 - Modify influent screen in the sump if significant clogging is observed
 - If overflows are observed, incorporate automated pump controls
 - Evaluate capacity of filter tank overflow pipe to prevent tank overtopping
 - Conduct additional media rinsing until low turbidity goal is met
 - Clarify tank draining procedures and rules to address vector concerns

- Recommendations:
- Continued inspection and maintenance of all BMPs
 - Consider March recommendations
 - Add sandbags along rip-rap, extend matting over the sides of the ELV channel, and weight down matting with pass-through bags
 - Collect stormwater samples at the midpoint between sedimentation basin and media filter.
