Improving the Service Life of

FLIGHT DECK

WINDSHIELDS

JOHN HUFF
SERVICE ENGINEER
COMMERCIAL AVIATION SERVICES
BOEING COMMERCIAL AIRPLANES

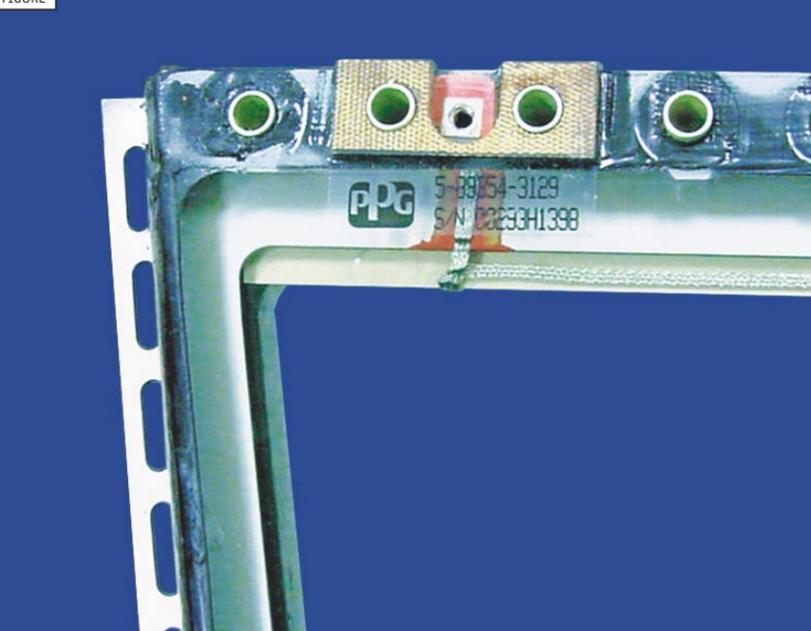
1 PART NUMBER DECAL — 737 NO. 1 WINDSHIELD

To determine the age and design configuration of a flight deck windshield, an airline must know the windshield part number, supplier name, and date of manufacture. Most windshield assemblies for Boeing-designed airplanes have a part number decal, or tag, located on the inboard side along the perimeter near the top of the windshield assembly (fig. 1).

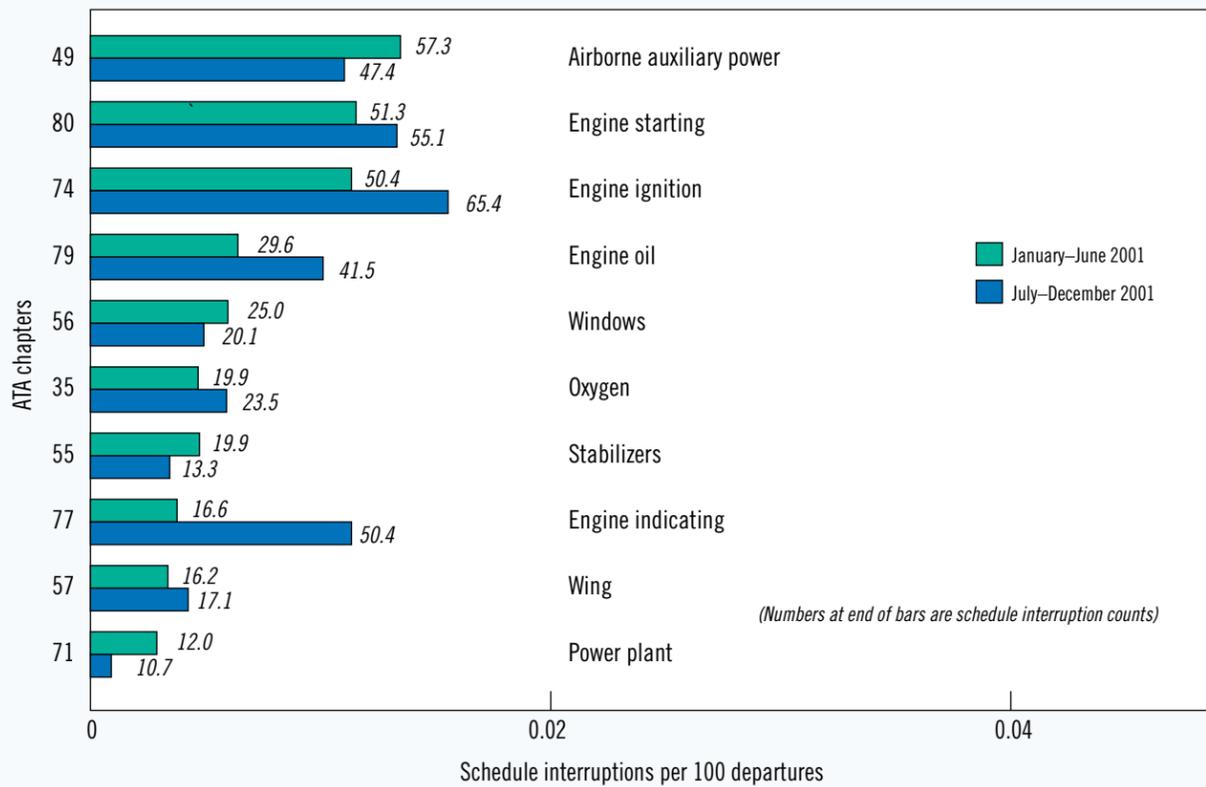
3 SYSTEM SCHEDULE INTERRUPTION SUMMARY

Figure 3 summarizes the causes of system schedule interruptions for 737-300/-400/-500 airplanes for two 6-month periods ending December 2001. Of the 30 items tracked by the Air Transport Association (ATA), windows (i.e., Chapter 56) were the 18th most significant cause of delay. Although ATA Chapter 56 covers all window-related delays, including those involving passenger cabin windows, it does provide an overall guideline for 737 flight deck windshields. (Data on

- Flight deck windshields no. 1 (left and right) and no. 2 (left and right) significantly affected system schedule reliability.
- Flight deck windshields manufactured before November 1992 lasted approximately 6,000 flight-hours (4 years) of in-service use before replacement, compared with 20,000 to 30,000 flight-hours (8–11 years) for those manufactured after November 1992. (The 737 analysis did not measure airplane utilization, which was not a meaningful factor because it was taken into account in the usage [flight-hours] measurement.)
