December 13, 2005 Meeting Status of NPDES Post Fire BMPs

Santa Susana Field Laboratory Regional Map

Impact To SSFL as a Result of September 2005 Fire

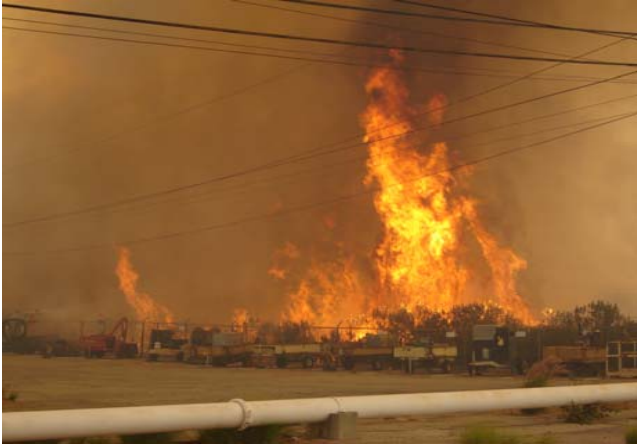
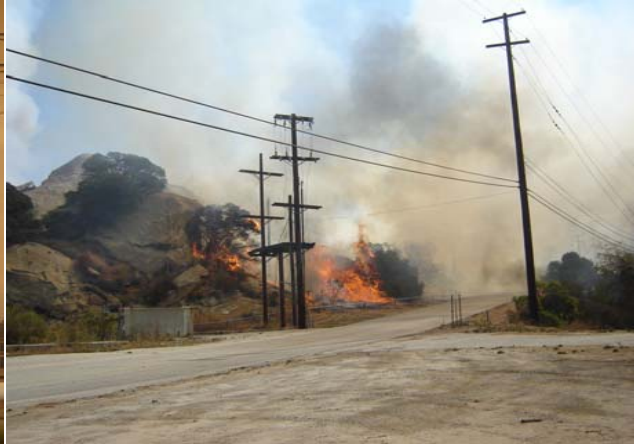
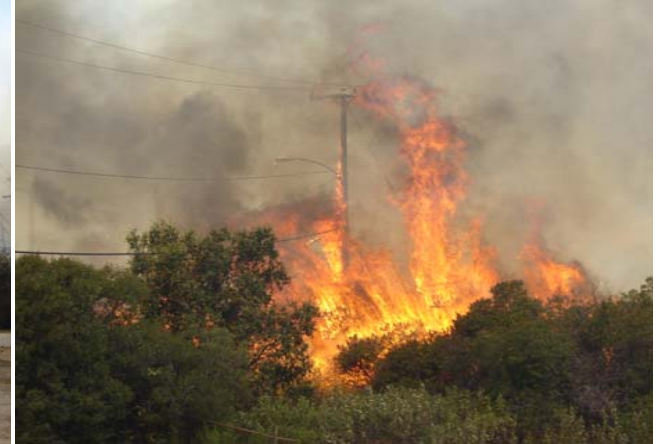
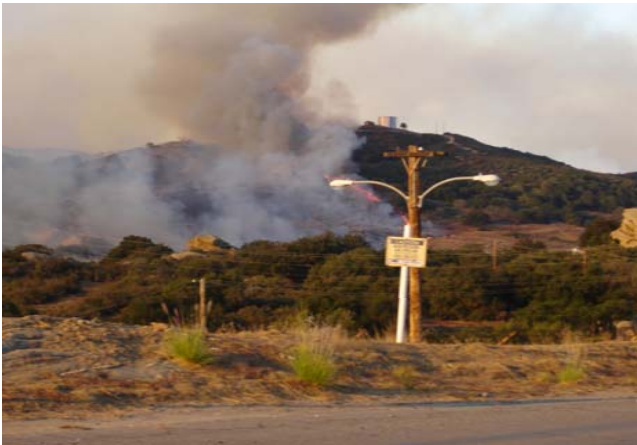
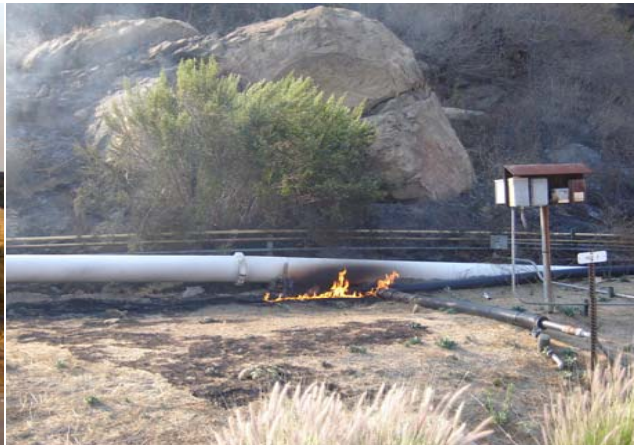
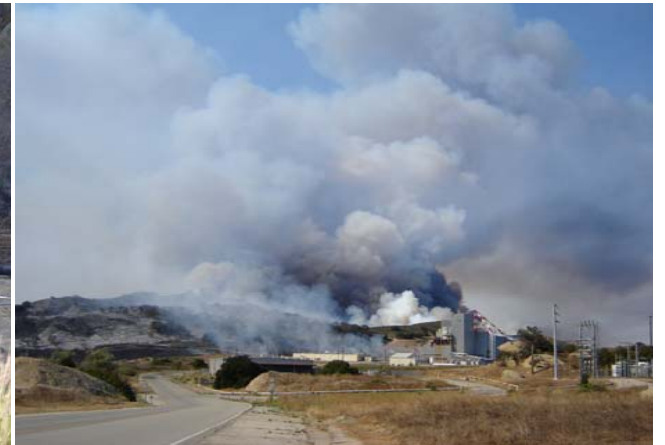
September 2005 Fire At SSFL

- Brush burned on over 2,000 acres of the site.
- 10 of the 200 structures were damaged by fire with 7 destroyed.
- Over 300 telephone and power poles were destroyed.
- High Density Polyethylene (HDPE) pipelines from the groundwater remediation systems were destroyed.
- DTSC, DOE, DHS, VCEHD, RWQCB and various fire departments have been on site to inspect and assess the fire damage.

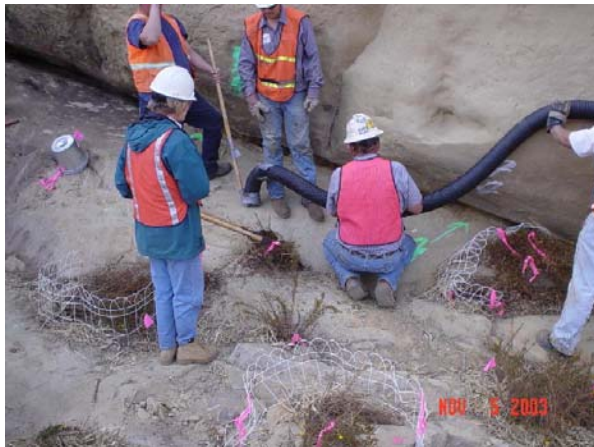
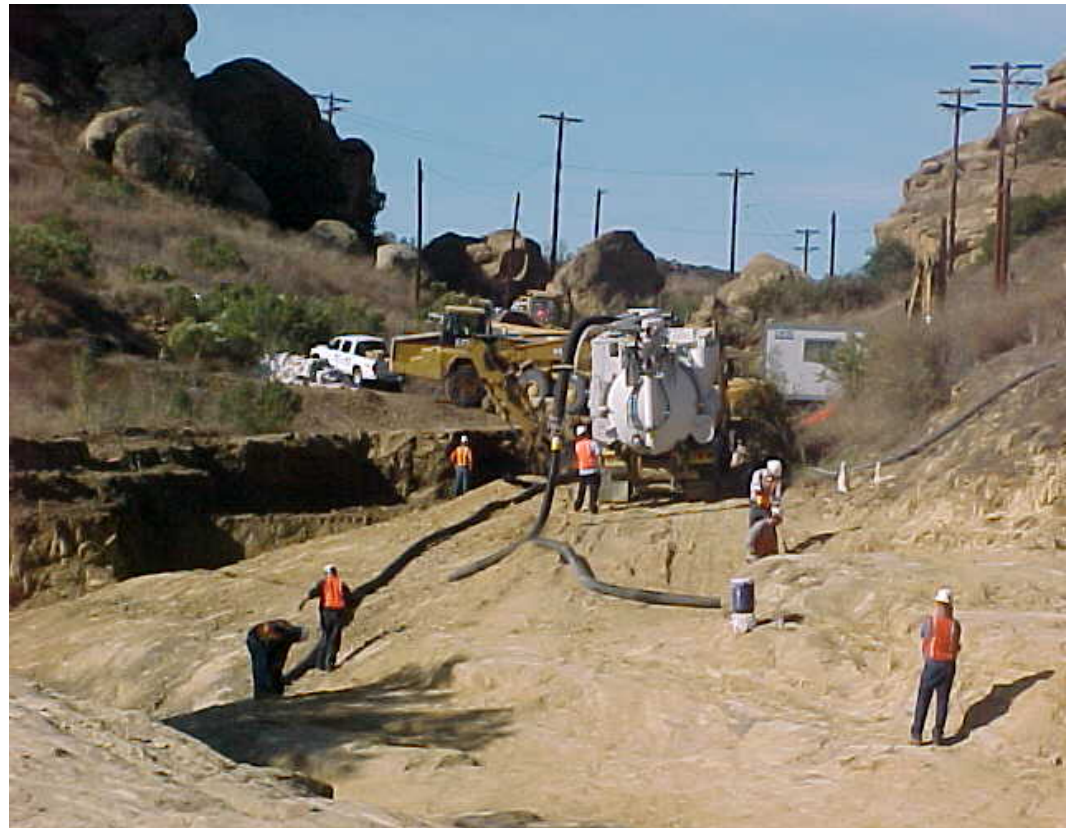
Recent Cleanup Projects: Soil Removal near Outfall 010. (Building 203)

- *Total soil excavated: ~8,000 cubic yards*
- Backfilling, re-vegetation and installation of erosion control measures completed
- Surface water monitoring (Outfall 008) confirm success of perchlorate driven Interim Measure

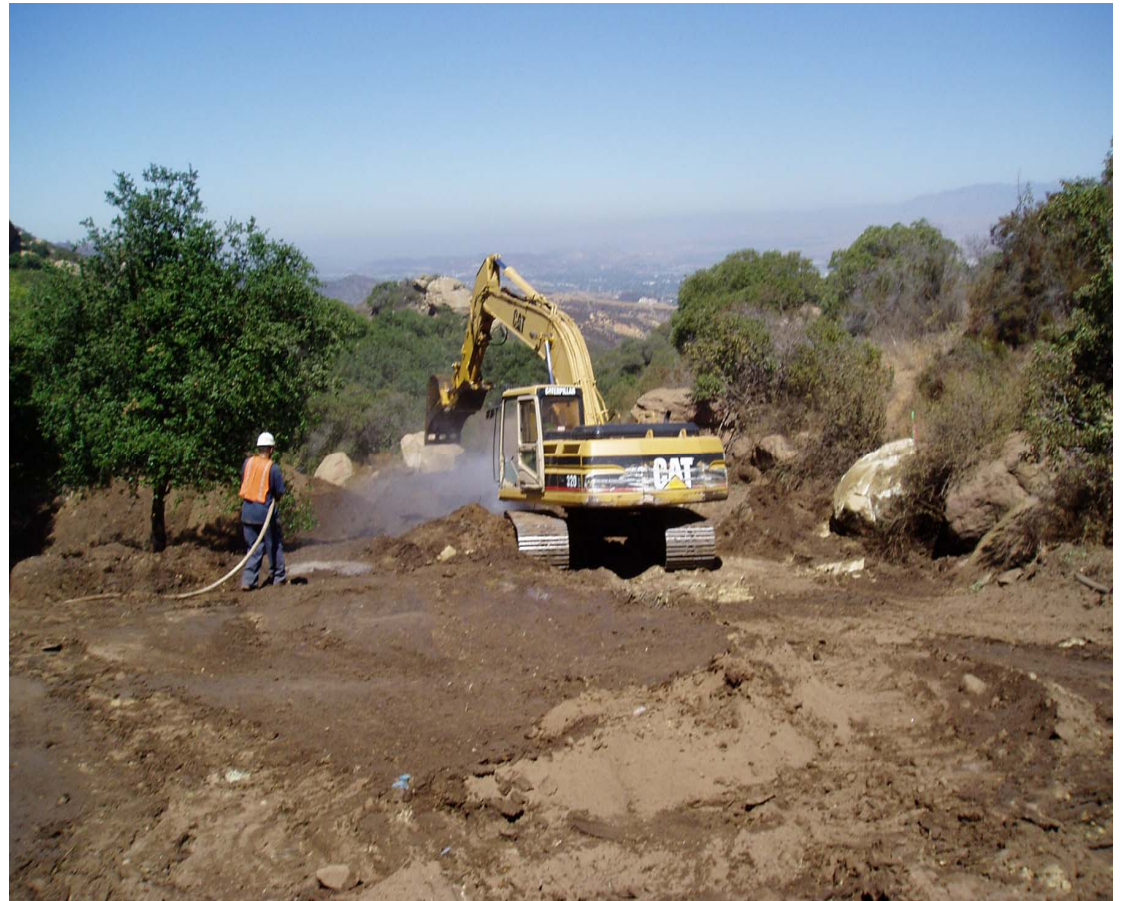
Recent Cleanup Projects: Soil Removal Near Outfalls 005 & 006 (Former Sodium Disposal Facility)

- 2004 soil removal action
- 3,000 cubic yards of soil removed

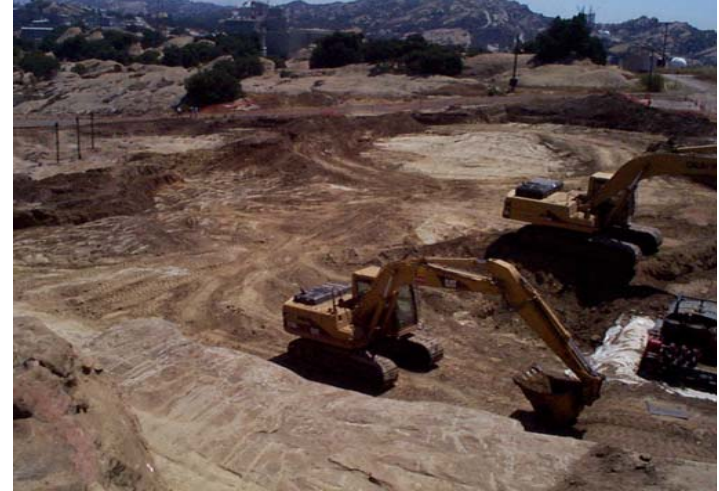
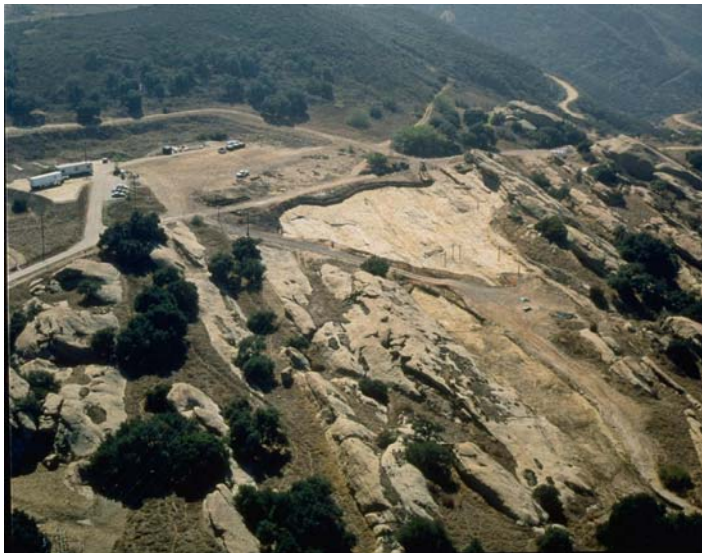
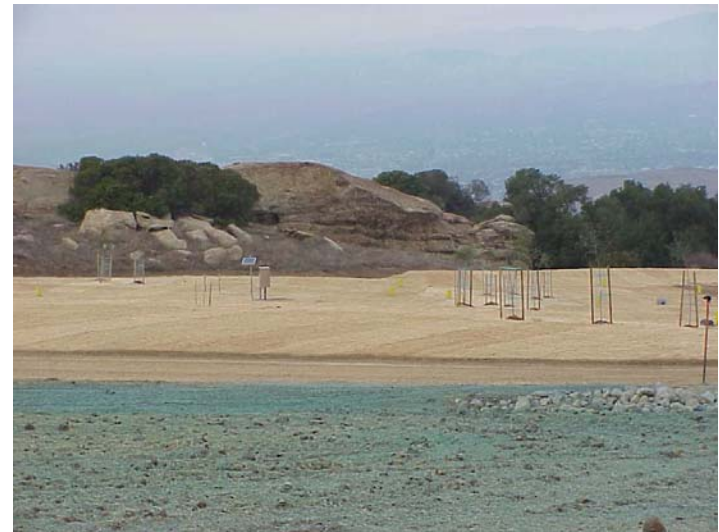
Completion of DOE (Area 4) FSDF Interim Measure

- 2000 soil removal action
- 14,900 tons of soil/sediment removed
- Helicopter lift
- Onsite soil borrow area
