Subject: 2014 Best Management Practices (BMP) Plan Addendum to the October 2010 Santa Susana Site Outfalls 008/009 Watersheds BMP Plan, Santa Susana Field Laboratory, Ventura County, CA (Order No. R4-2010-0090; NPDES No. CA0001309, CI No. 6027)

**2014 BMP PLAN ADDENDUM**

**SANTA SUSANA SITE**

September 30, 2014

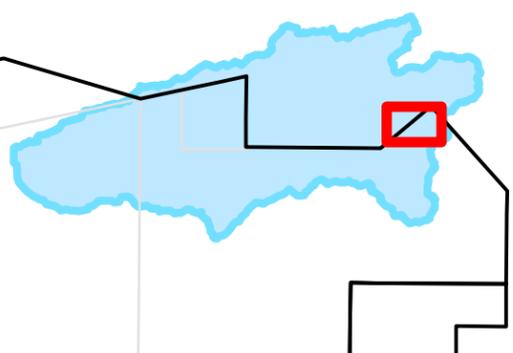
**Figure A3: B1  
 BMP Recommendations**

During a site visit in August 2014, the Expert Panel observed erosion rills at the top of the slope adjacent to and upstream of the B-1 media filter. When evaluating solutions to prevent erosion at this location, extensive reworking of the hillside was considered but deemed infeasible since this would require removing existing vegetation and performing major grading on a very steep slope in close proximity to the B-1 media filter. Therefore, to prevent the rills from expanding and additional erosion from occurring, the Expert Panel recommends the following robust inspection and maintenance procedures (Figure 6):

**Inspect the existing sandbag berm at the top of the slope upstream of the media filter to ensure it has no gaps; repair/replace as necessary (See Figure 7 in text).  
 Inspect the existing slope protection measures (and condition of rills beneath the erosion control blanket) and check dams along the channel; repair/replace or perform maintenance as necessary (See Figure 8 in text).  
 Inspect the existing silt fence around the B-1 media bed and outlet structure; repair/replace as necessary.**
