SANTA SUSANA FIELD LABORATORY

**NPDES OUTFALLS 008 & 009
SUMMARY OF ACTIVITIES**

March 20, 2013 **SSFL Stormwater Expert Panel** With support from
Geosyntec
consultants

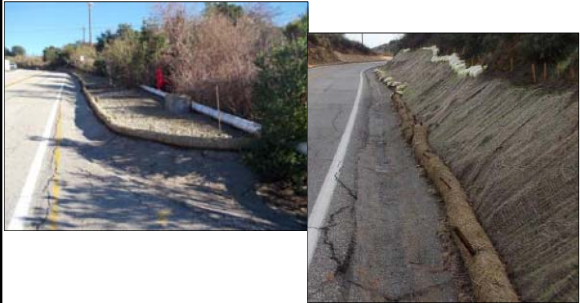
CM-9 Area

Erosion controls along road, upstream from CM-9

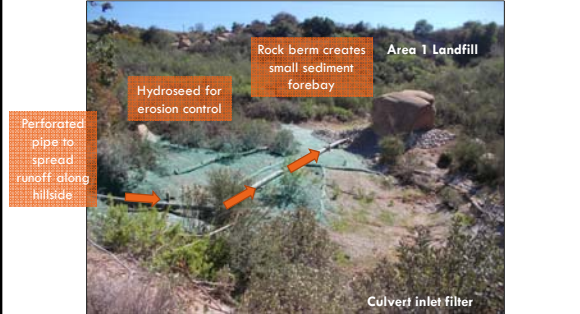
CM-9 Area

Perforated pipe to spread runoff along hillside

Hydroseed for erosion control

Rock berm creates small sediment forebay
