# SANTA SUSANA FIELD LABORATORY

## PUBLIC MEETING SITE-WIDE SUMMARY OF ACTIVITIES

July 25, 2018

SSFL Stormwater Expert Panel

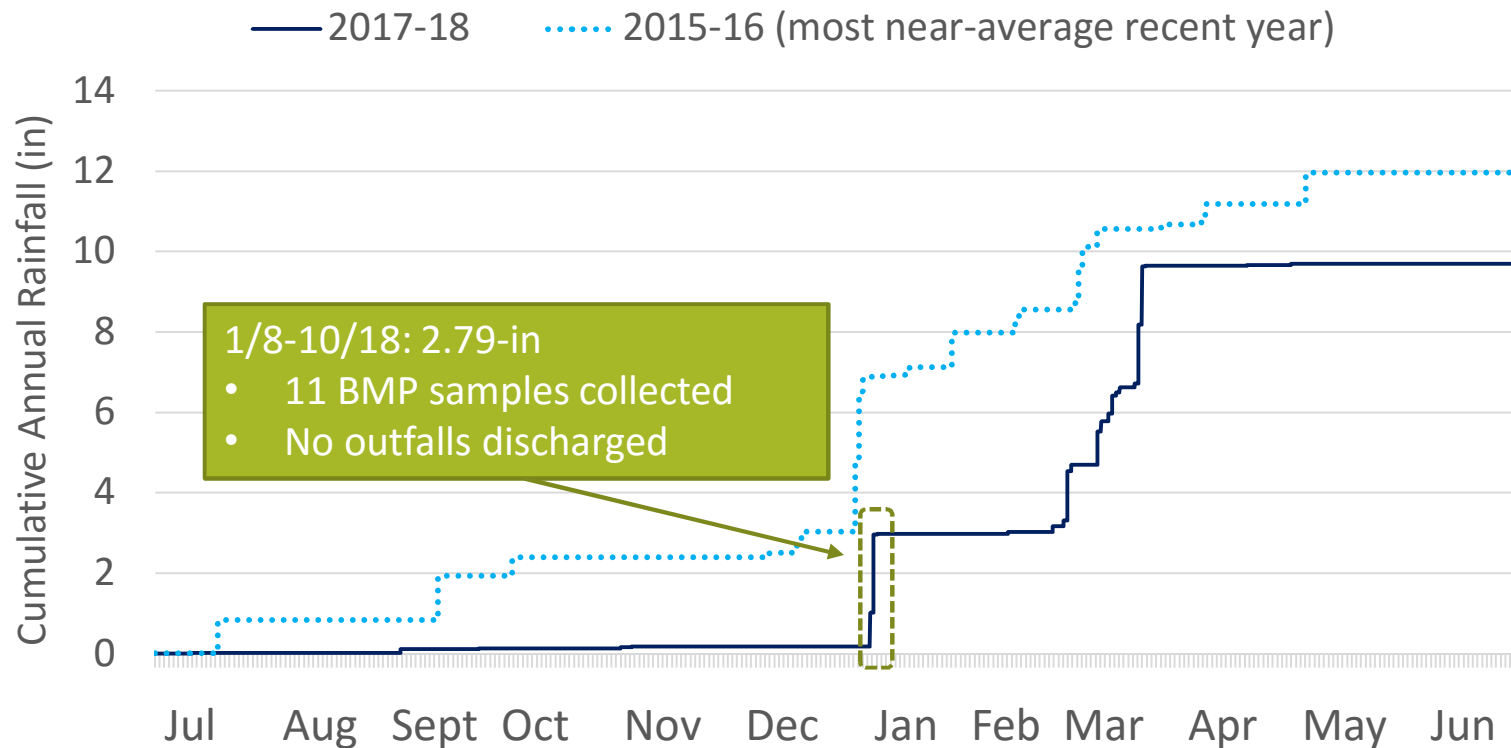
# 2017-18 Rainfall Summary

- Four qualifying rain events (>0.10-in in 24-hrs)
- Total annual rainfall 9.75-in (vs. 16.8-in average)

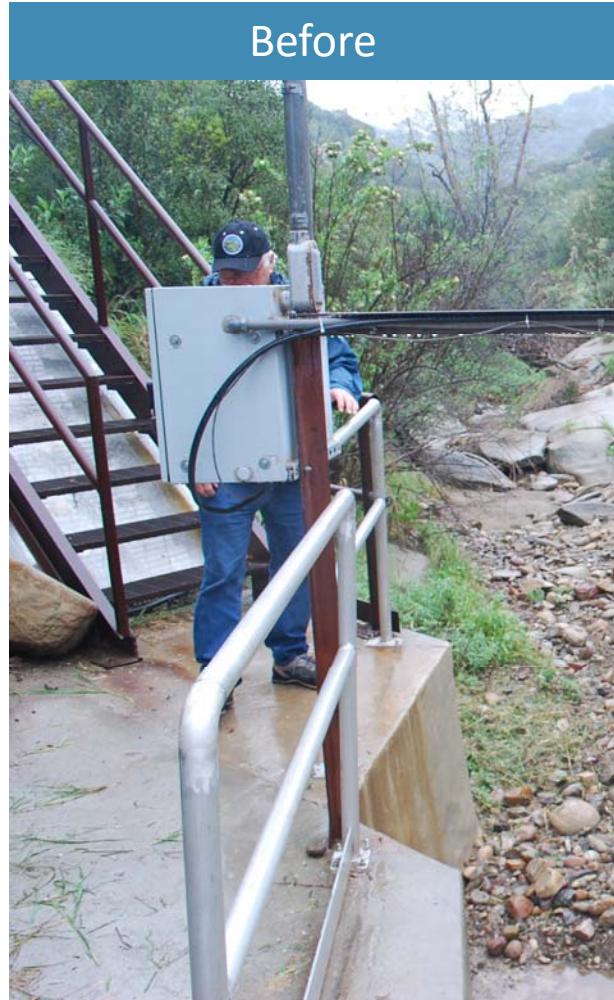
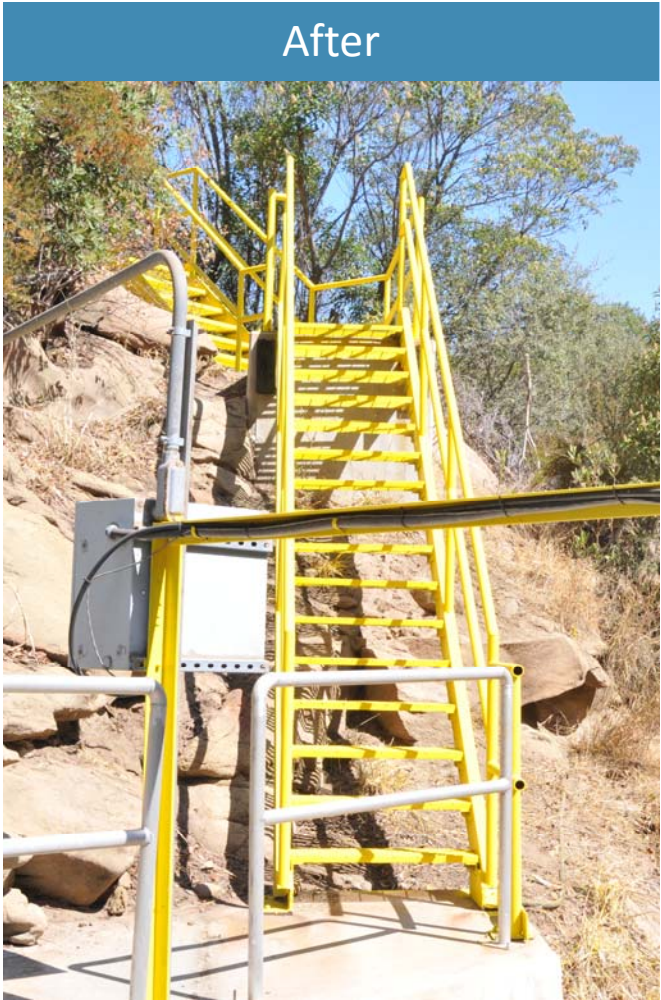
# Addressing Metal Structures

Iron structures in the upstream areas have been painted.

- Outfalls 009 and 002 discharged only during the last event
- No exceedances at Outfall 009
- One exceedance at Outfall 002
  - Iron result = 2.1 mg/L
  - Benchmark limit = 0.3 mg/L
  - Potential sources may include:
    - Background soils
    - Metal structures

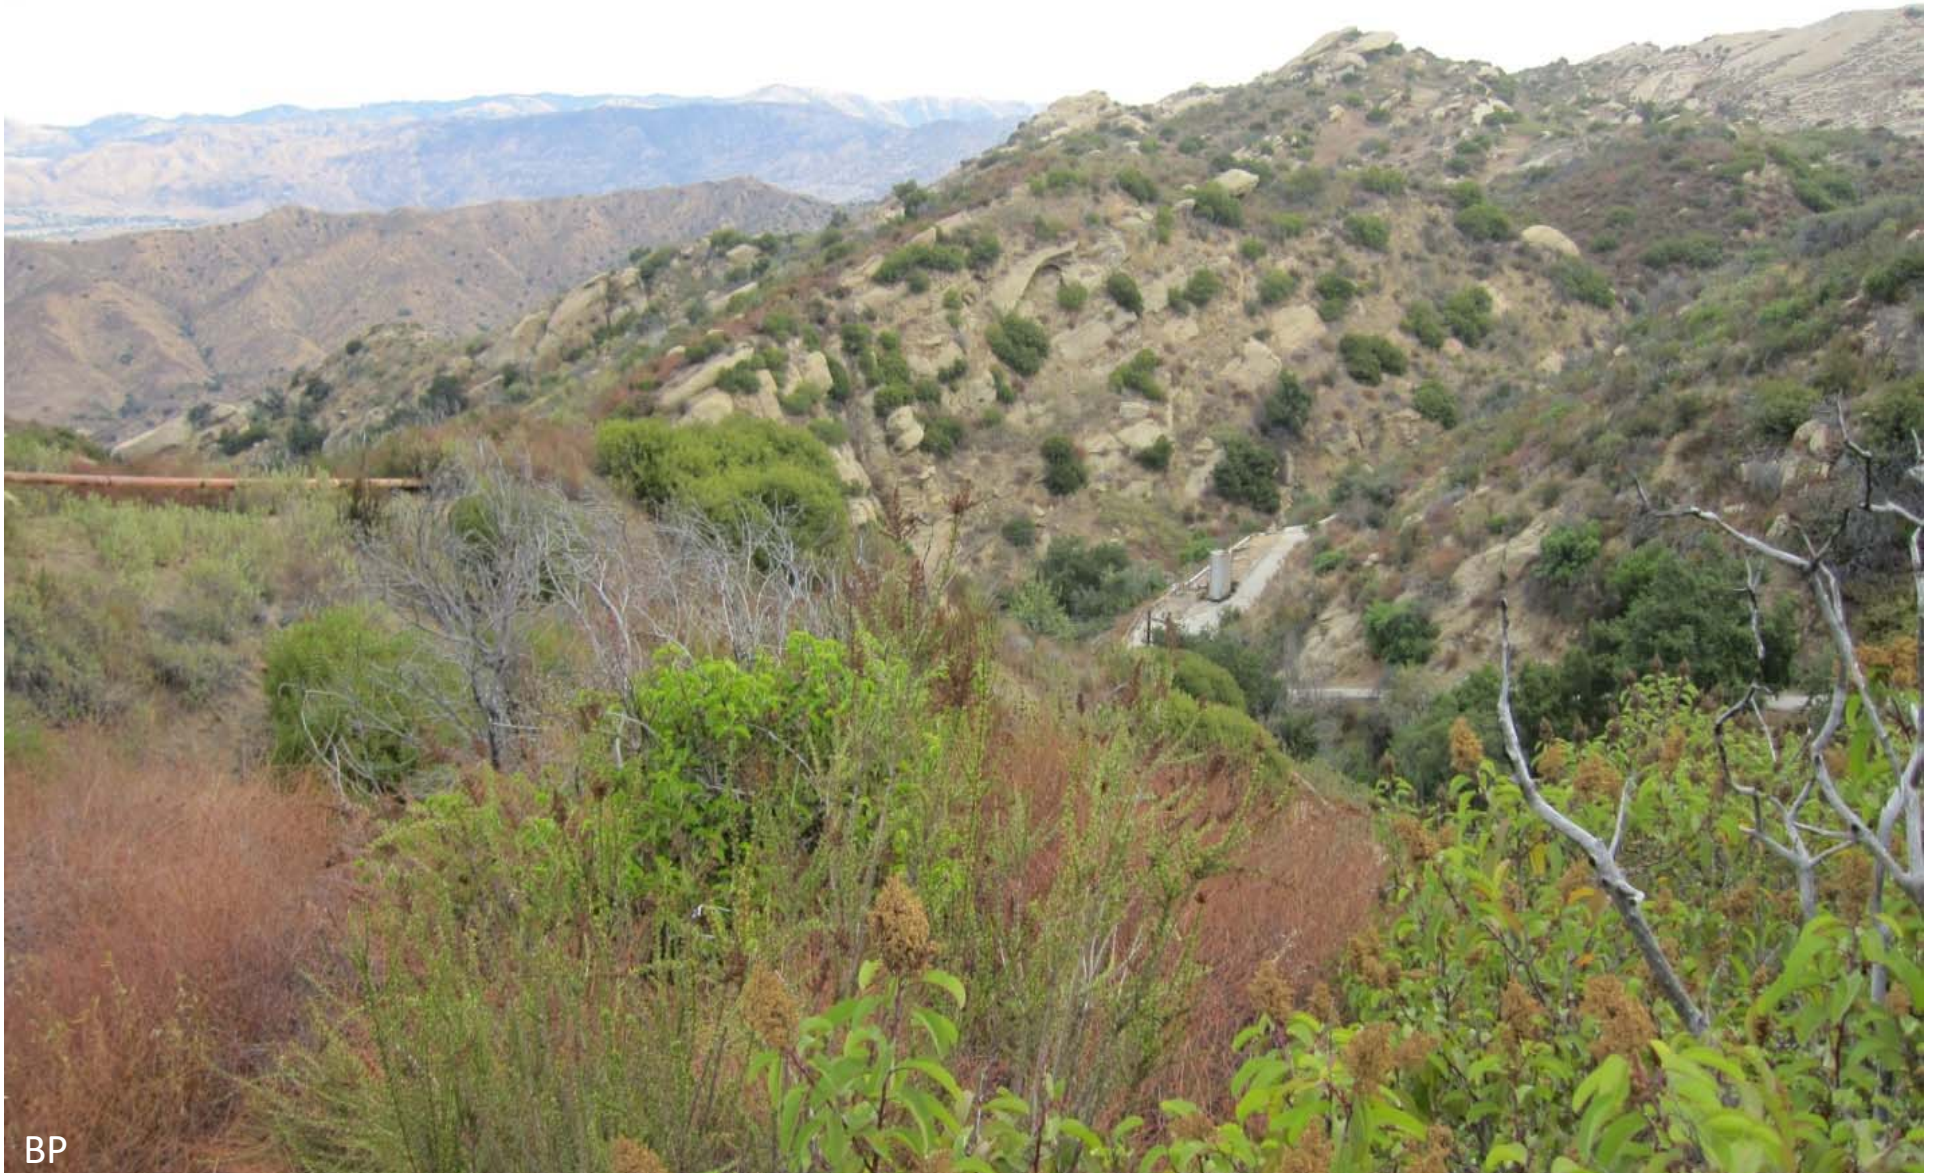
# BMP Strategy for 008/009 Watersheds

- **Source Controls**
  - ISRA soil removal
  - Pavement and building removal
- **Erosion/Sediment Controls and Restoration**
  - Hydroseed/mulch, plantings, etc.
  - Dirt road controls
  - Channel stabilization controls
- **Treatment Controls**
  - Flow-through media filters
    - Culvert modifications
    - B1, upper lot media filters
    - Sedimentation basin and biofilter
    - ELV treatment BMP
    - Admin area filters
  - Detention bioswales
  - Temporary sedimentation areas (LOX, helipad)

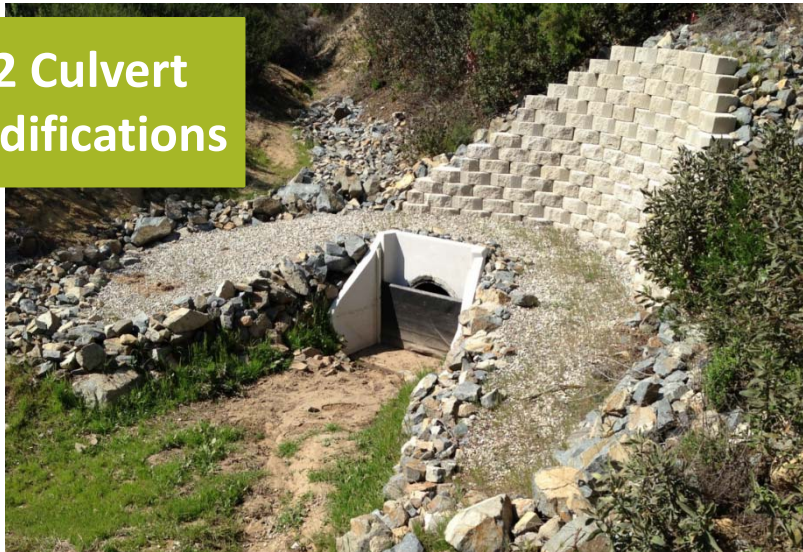
12 Culvert Modifications

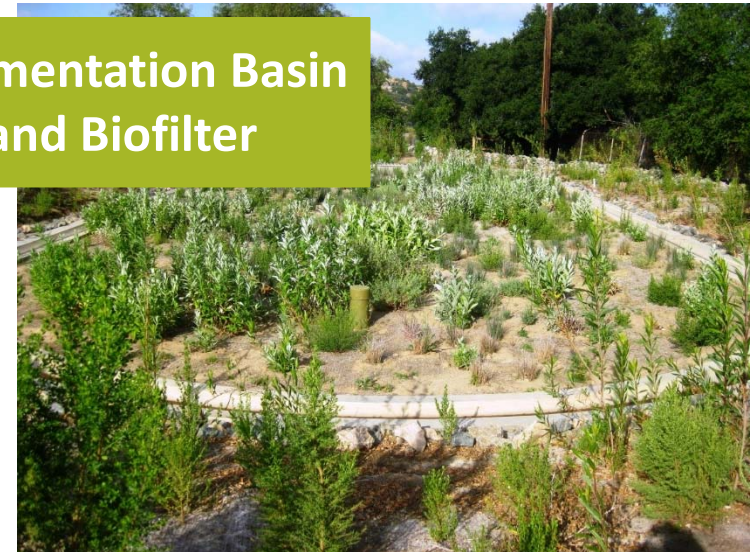
Sedimentation Basin and Biofilter

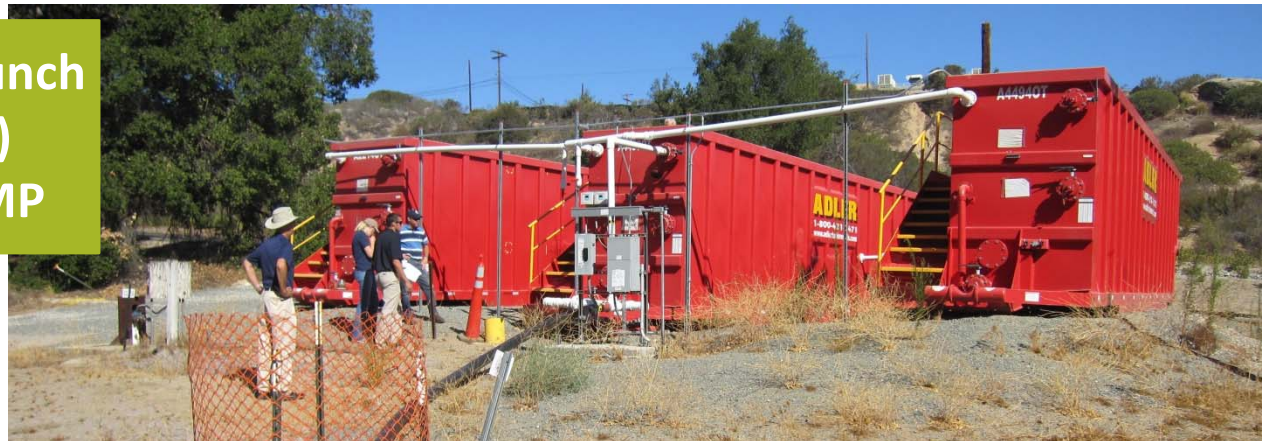
Expendable Launch Vehicle (ELV) Treatment BMP

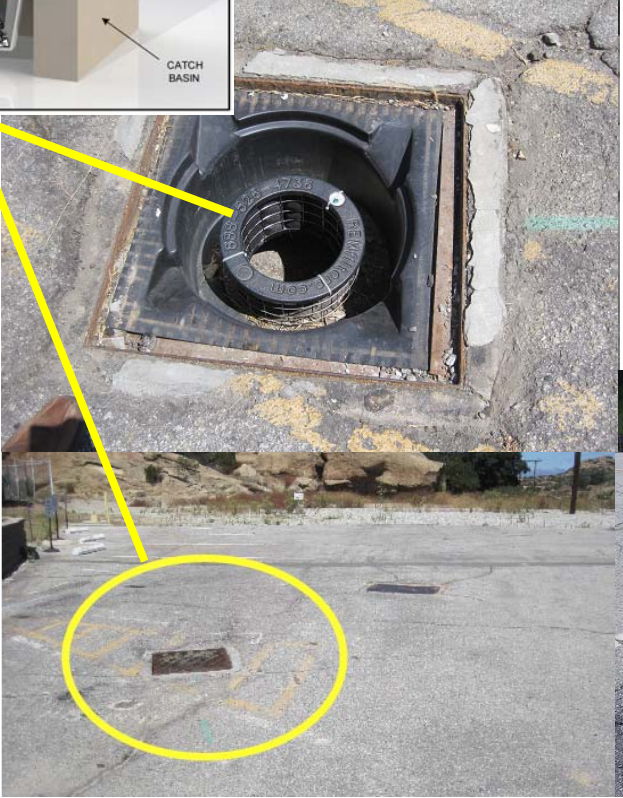
Drop Inlet Filters filled with Site Media (Sand, GAC, Zeolite)

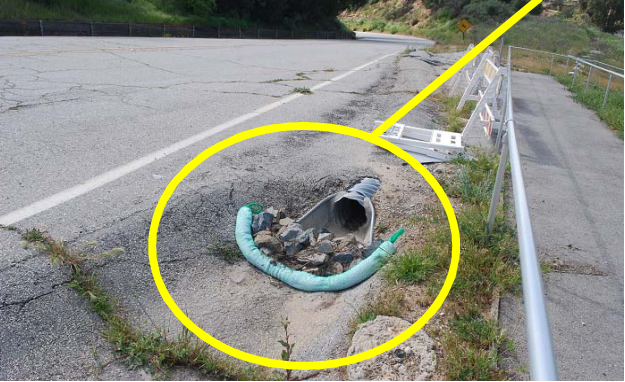
Weighted Wattle filled with media (Perlite, GAC, Zeolite)

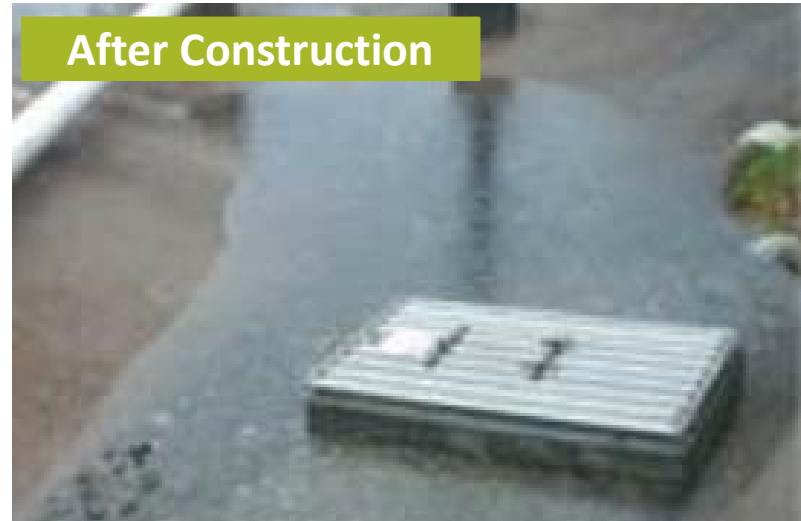
# Upper Parking Lot Media Filter

During Construction

- Expected years to needed media replacement (based on total suspended solids loading) is evaluated annually for each media filter
- Inspections are also conducted 72-hours after each rain event to make note of extended ponding
- CM-1 media replacement is currently recommended per the TSS loading estimate and ponding observations; CM-1 to be reconstructed later this summer
- Other media filters are estimated to have 2 to 30+ years of useful media life remaining

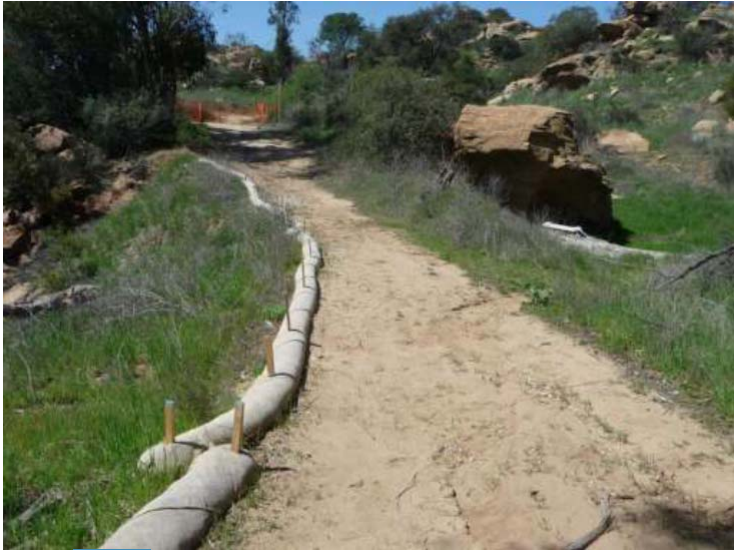
Fiber rolls

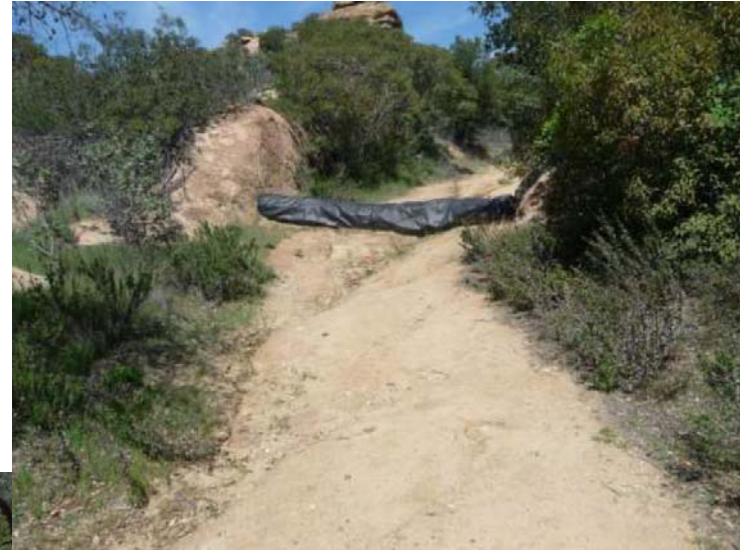
Sandbag berms

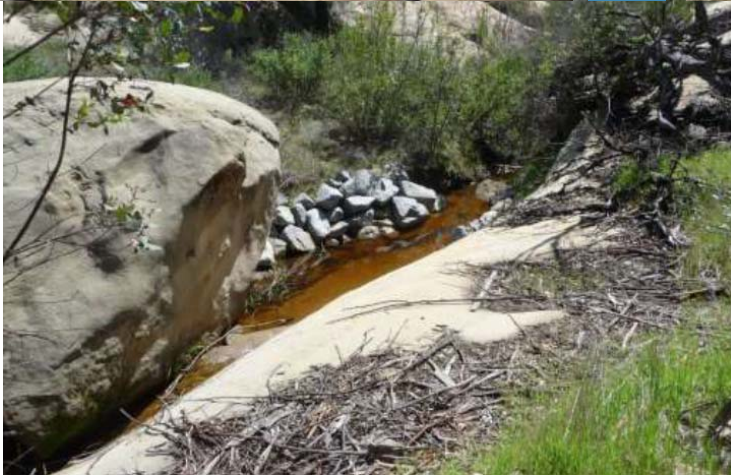
Bank stabilization

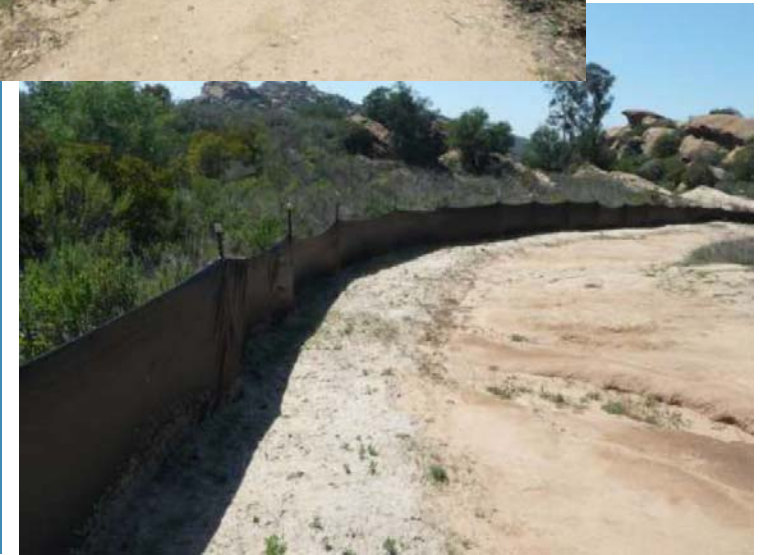
Silt fencing

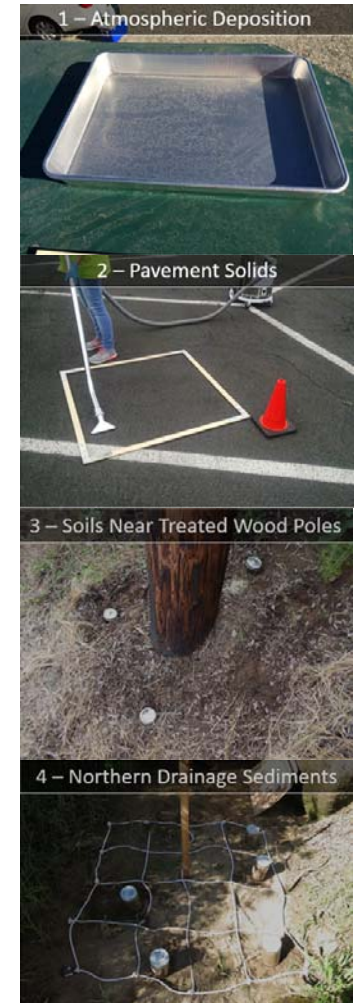
# Special Study Preliminary Results

- Study Objectives
  - Where (spatially) are dioxins and lead in stormwater predominantly coming from within 009 watershed?
  - What are the predominant pollutant sources to the paved subareas?
- Initial results indicate potential contributors to past OF009 stormwater exceedances:
  - Dioxins
    - Soils near treated wood
    - Fine solids from all pavement types
  - Lead
    - Atmospheric deposition
    - Fine solids from higher traffic roads
    - Shooting range soils not a significant current contributor to the Northern Drainage, and ISRA addressed other surface soils in watershed
- Sampling is ongoing

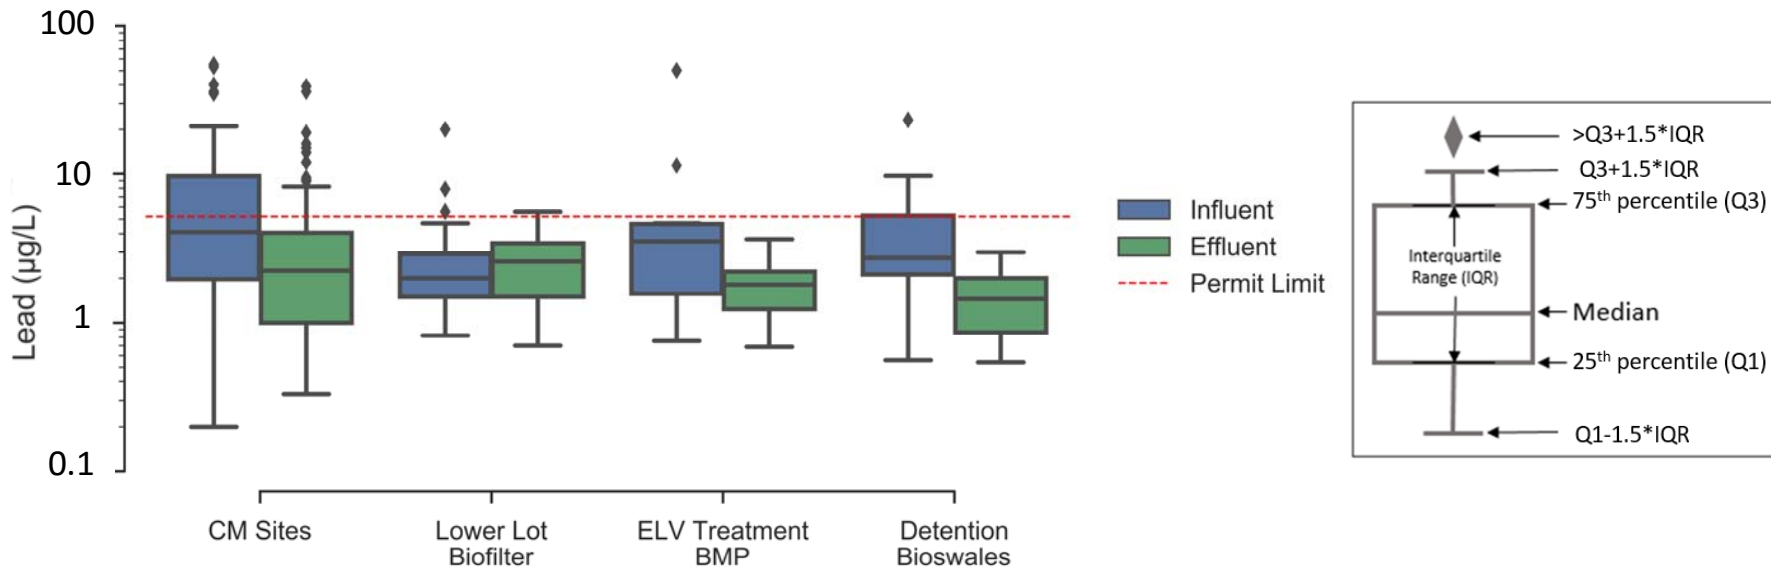
# Historical BMP Performance: Lead

Historically, lead concentrations are being significantly reduced for most BMP types

The figure above summarizes all available data, but in the most recent dataset (2017-18):

- Nearly all BMP influent results were below the lead Permit limit
- No measured BMP effluent results were higher than the lead Permit limit
- No lead exceedances were measured at Outfall 009 (during the only discharge event)

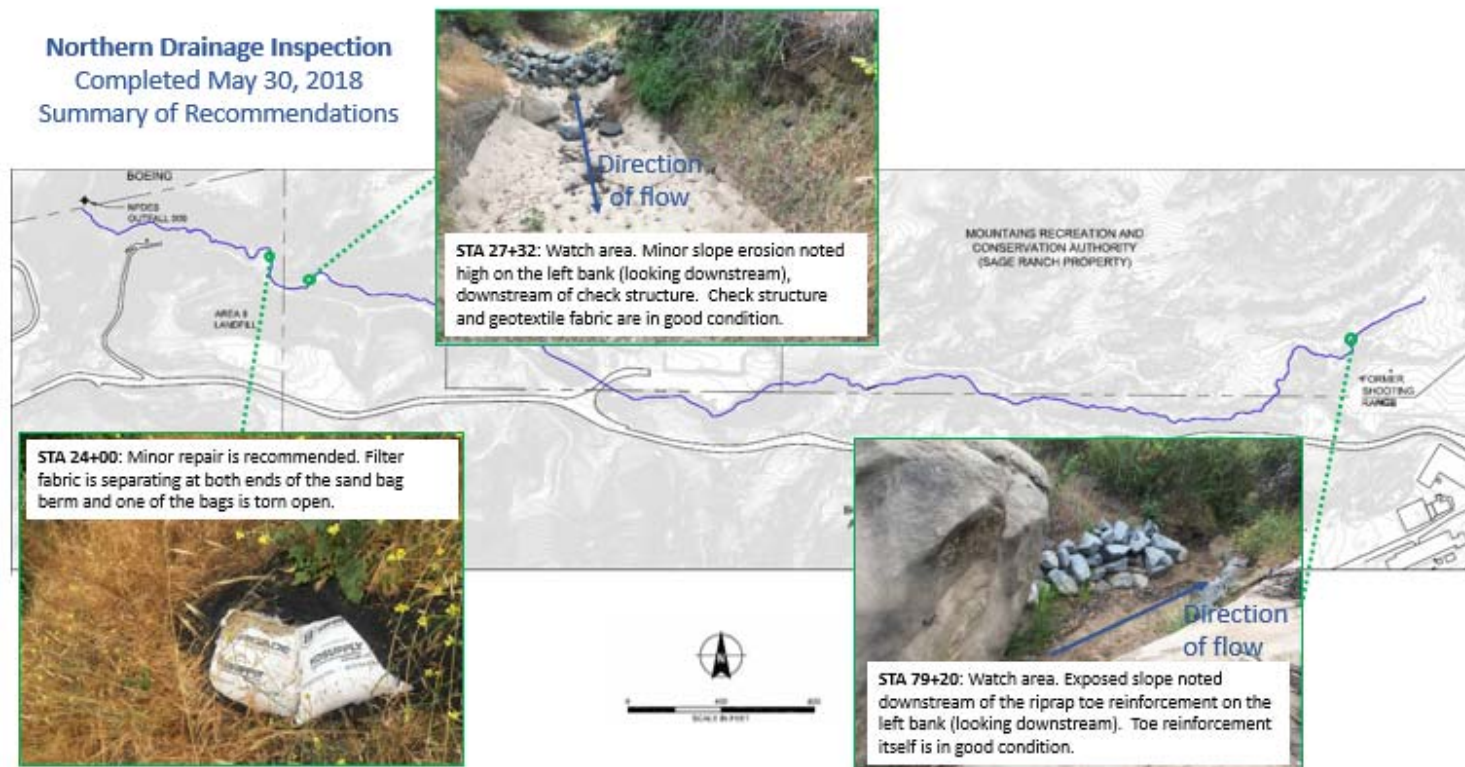
# Northern Drainage Inspections

- Inspection conducted May 30, 2018
- 1 recommendation for repairs and 2 watch areas

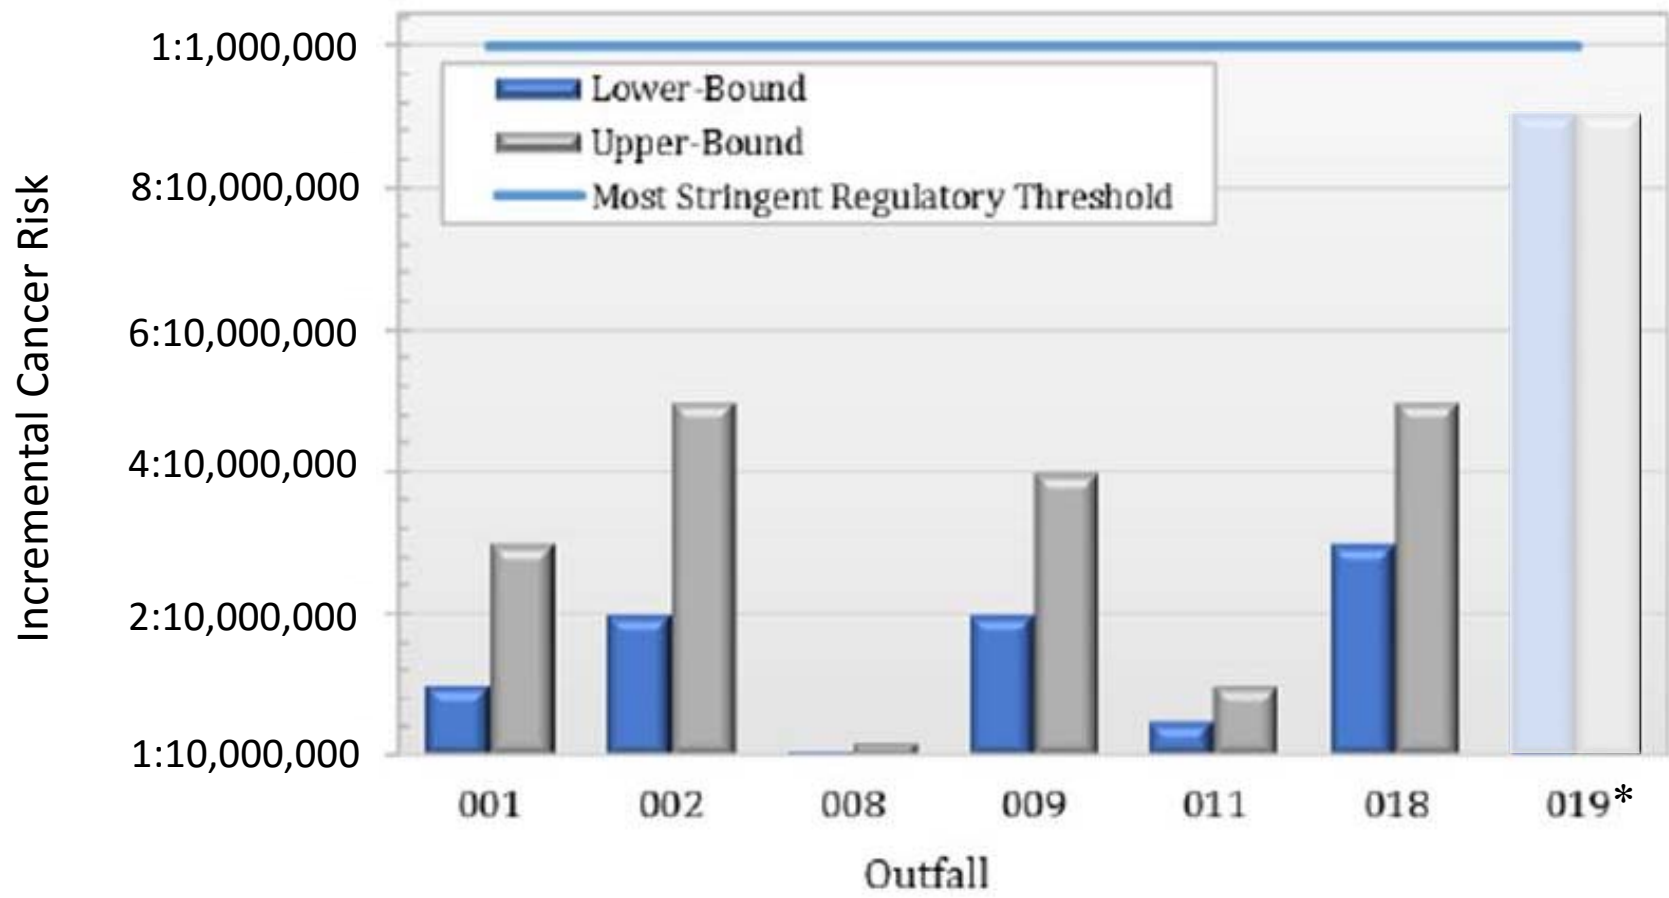
# Comparison of Lower and Upperbound Cumulative Incremental Cancer Risk Estimates by Outfall

\*Outfall 019 is not planned to be used for surface water discharge

- Potential recreational exposure via incidental ingestion and dermal contact in surface water runoff exiting the SSFL via Outfalls 001, 002, 008, 009, 011, 018, and 019 **are below levels of concern as established by CalEPA and USEPA** (see chart on next slide).
- Volatilization/inhalation risk is insignificant
- Edible aquatic plant risk is insignificant
- Fish consumption does not occur onsite and SSFL flow contributions to nearest downstream fishing locations are insignificant

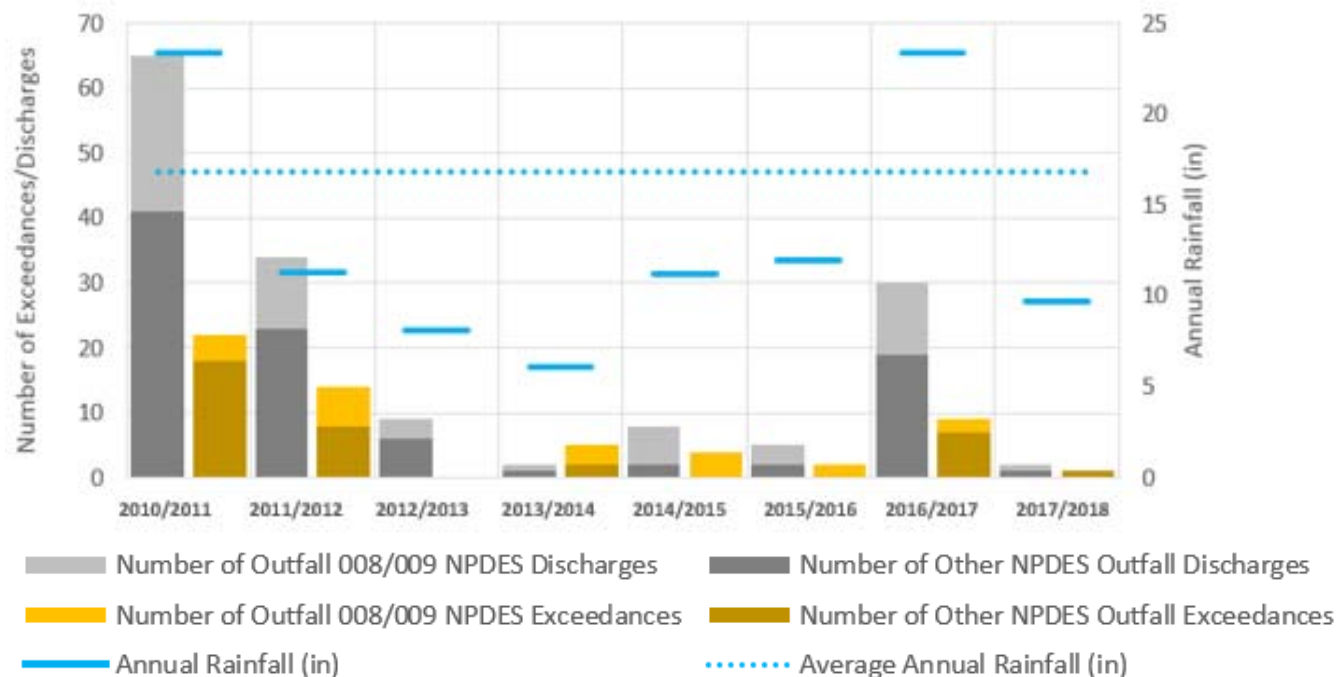
**A:** There were no Permit Limit exceedances at any NPDES Outfalls this season. There was one benchmark limit exceedance at Outfall 002, for iron. Additionally, both discharges and exceedances have been reduced over time.

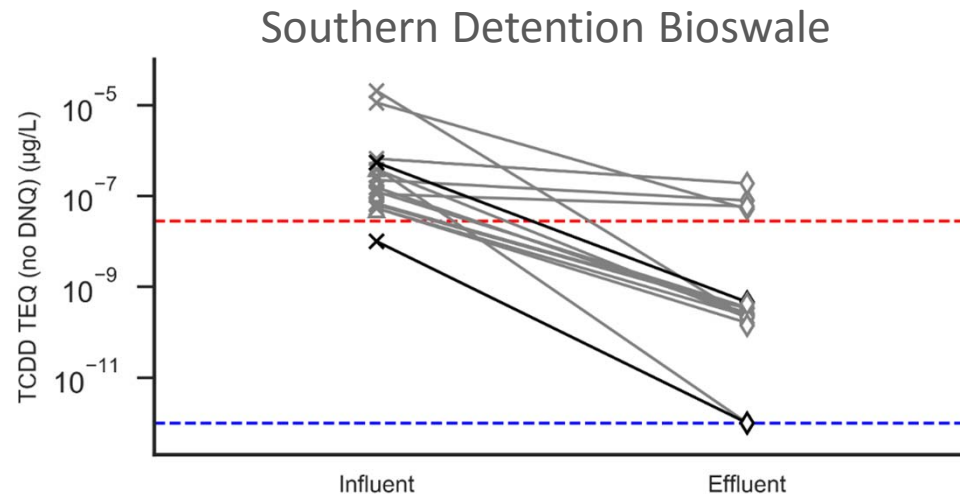
**A:** Significant performance data have been collected (nearly 150 influent/effluent pairs) and demonstrate that all BMPs are highly effective at reducing their targeted pollutants.

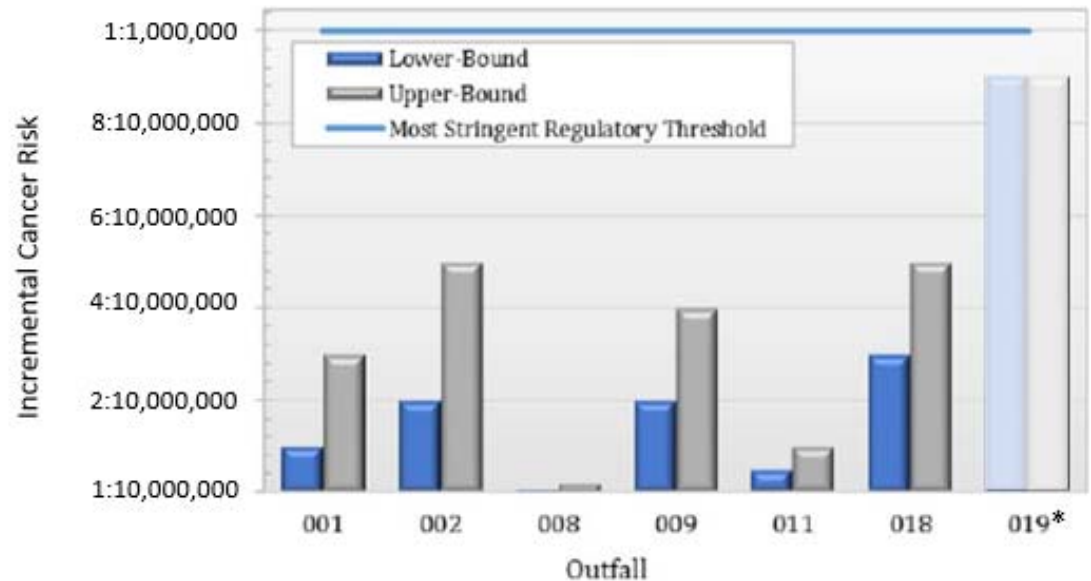
**A:** Potential recreational exposure via incidental ingestion and dermal contact in surface water runoff exiting the SSFL are below levels of concern established by CalEPA and USEPA.

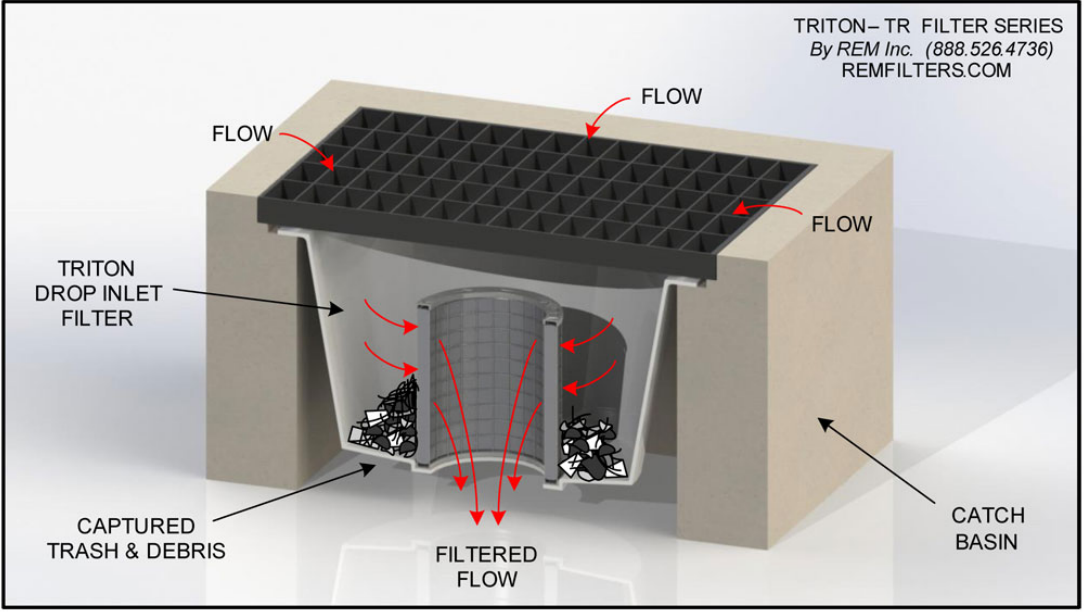
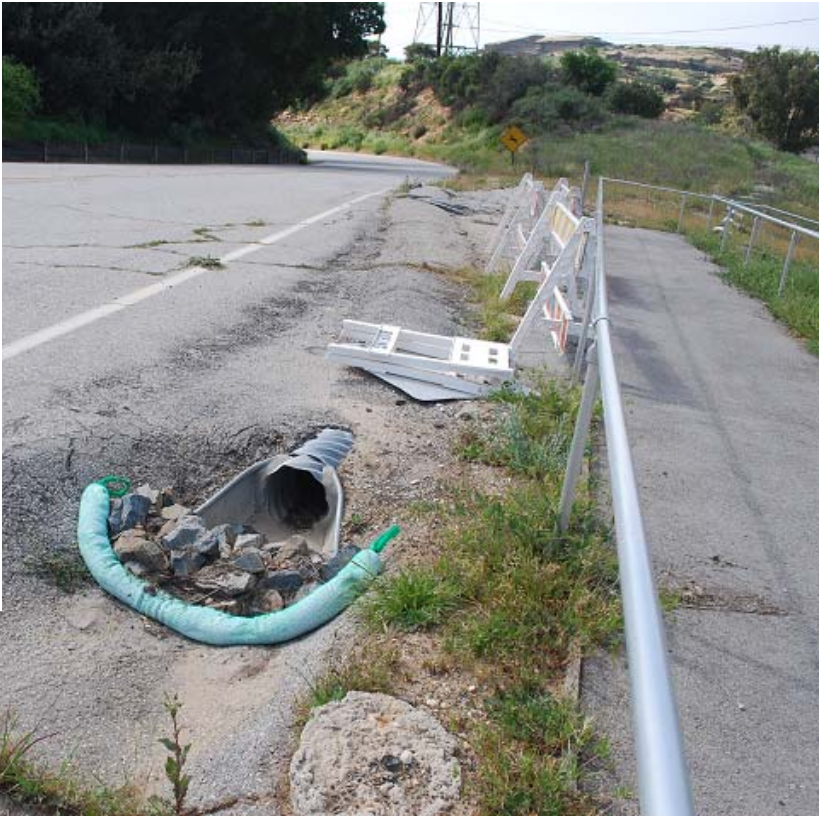
# Stop 1 (on foot)

- Administration area inlet filters
- Detention bioswales

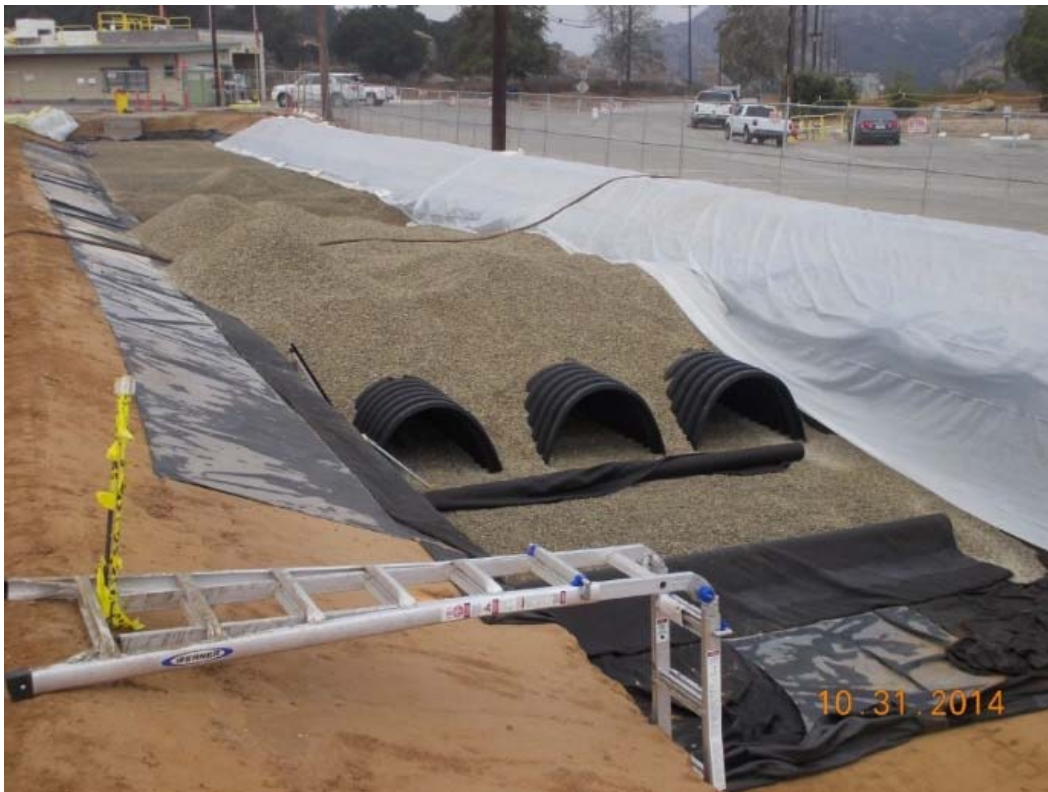
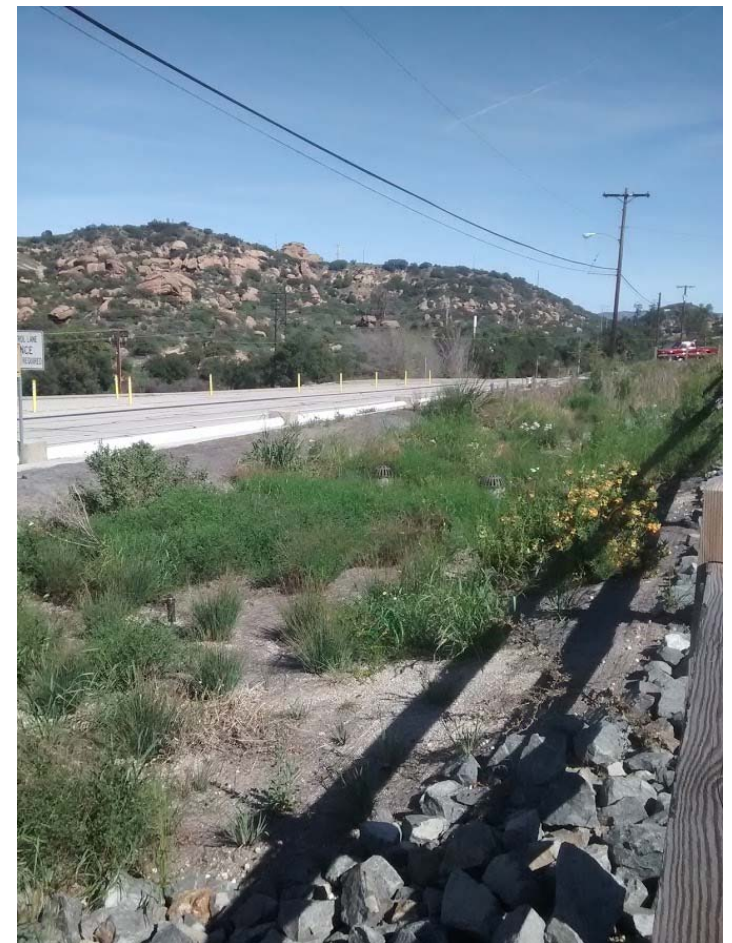
# Stop 1 (on foot)

- Administration area inlet filters
- **Detention bioswales**

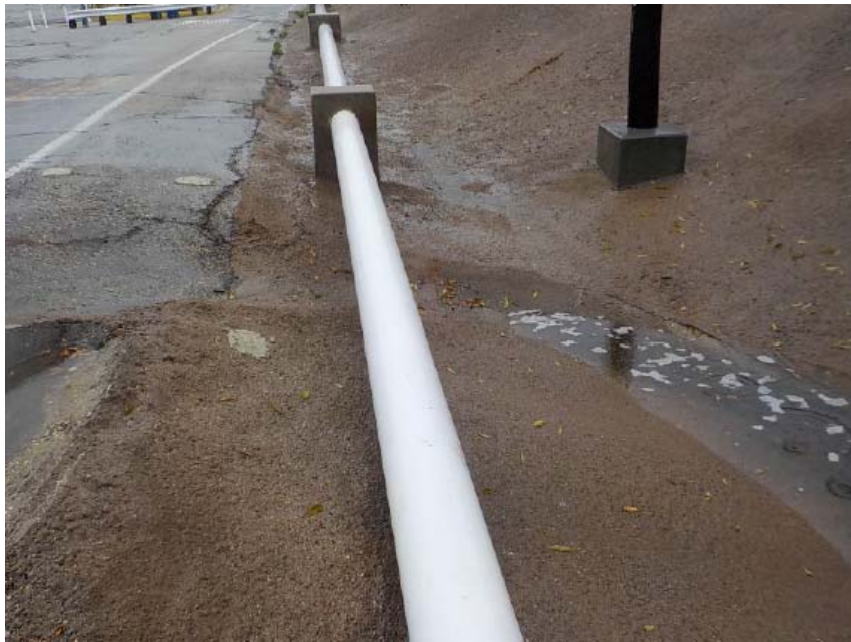
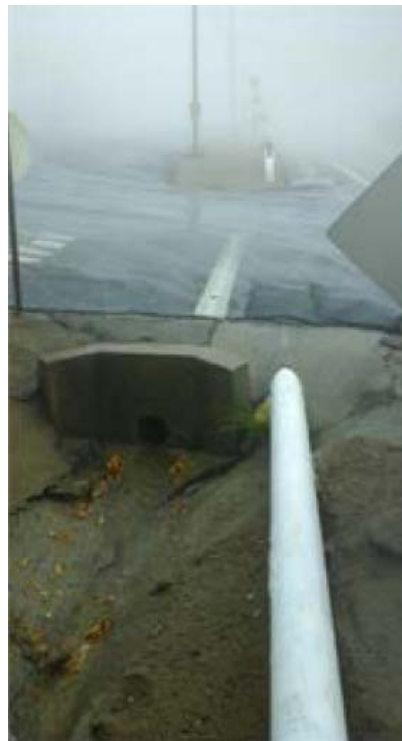
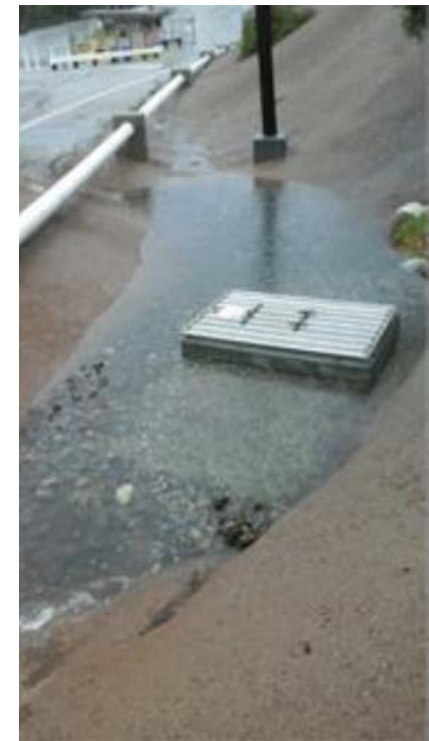
# Stop 2 (from bus)

- Upper lot media filter
- Lower lot sedimentation basin and biofilter

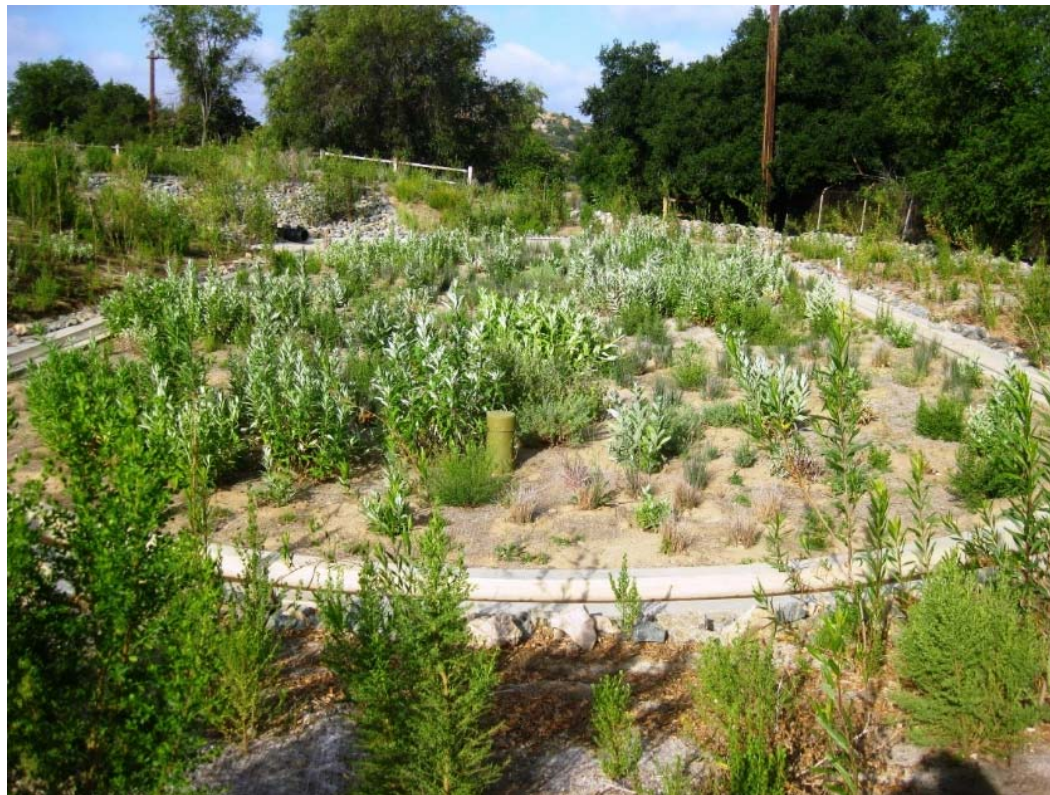
# Stop 2 (from bus)

- Upper lot media filter
- Lower lot sedimentation basin and biofilter

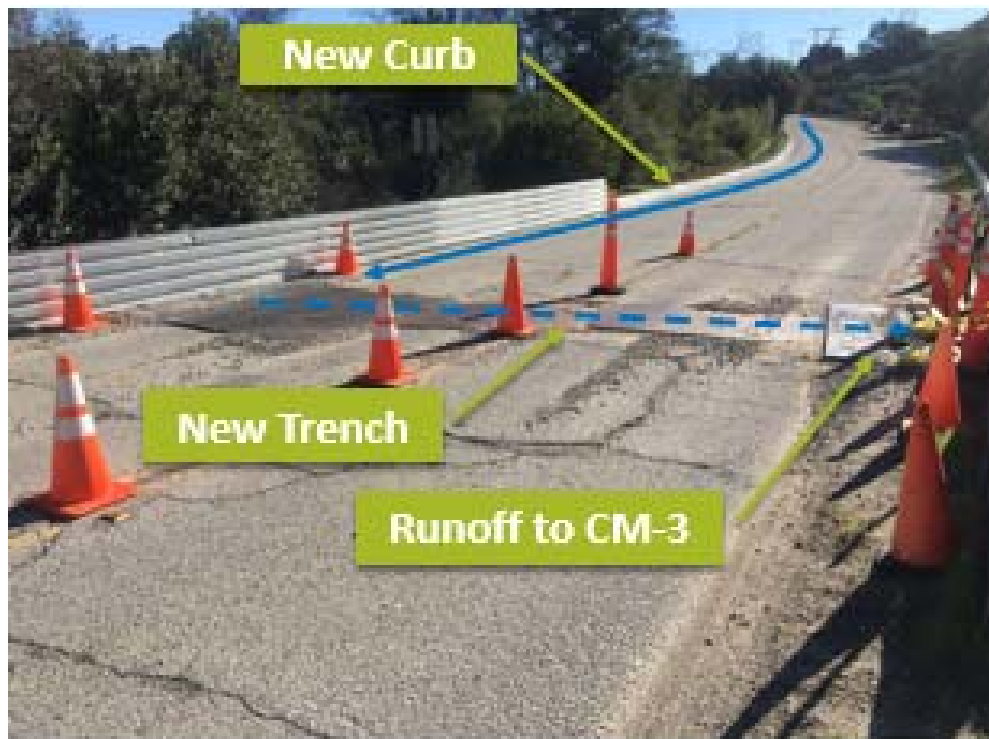
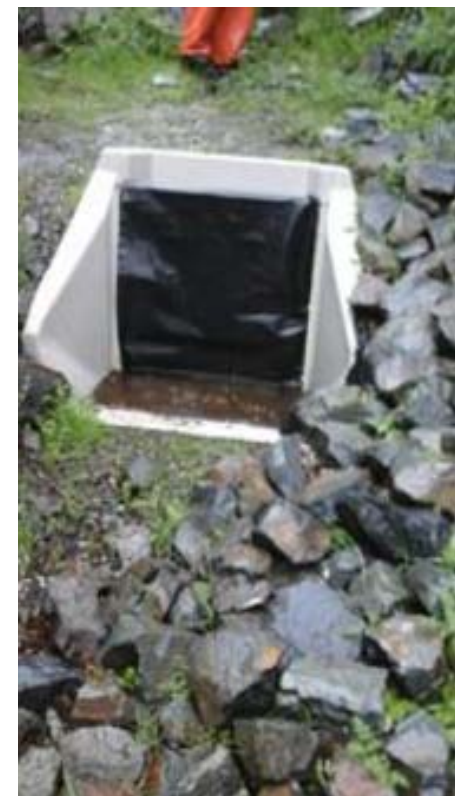
# Stop 3 (exit bus)

- CM-3 storm drain diversion
- CM-1 storm drain diversion
