# SANTA SUSANA FIELD LABORATORY

## PUBLIC MEETING SITE-WIDE SUMMARY OF ACTIVITIES

July 25, 2018

SSFL Stormwater Expert Panel

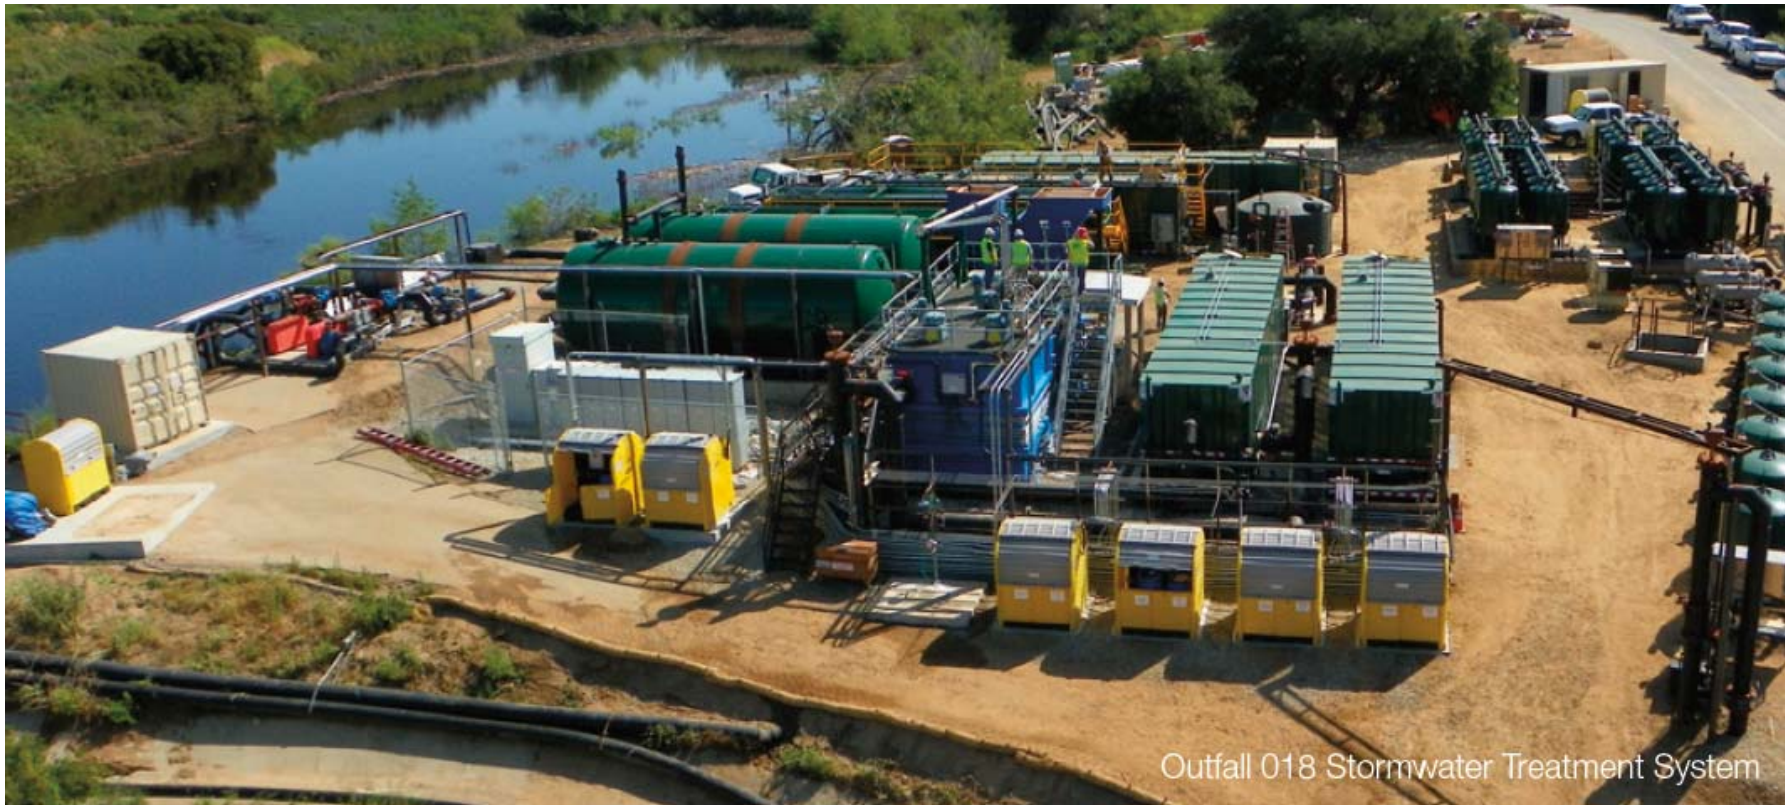
# Stop 4 (exit bus)

- **Outfall 018 stormwater treatment system**
