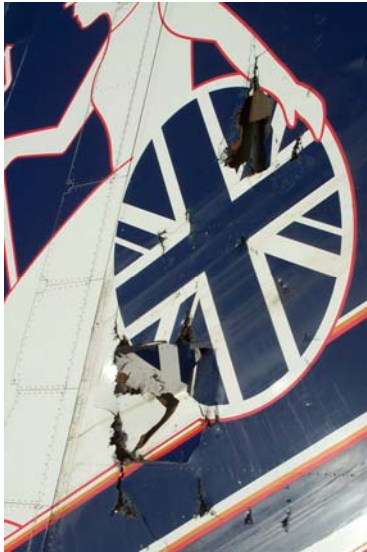
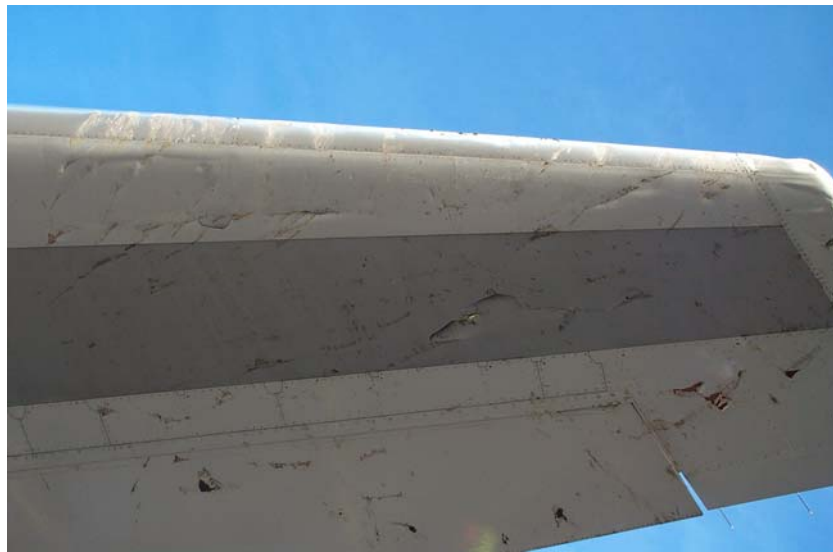
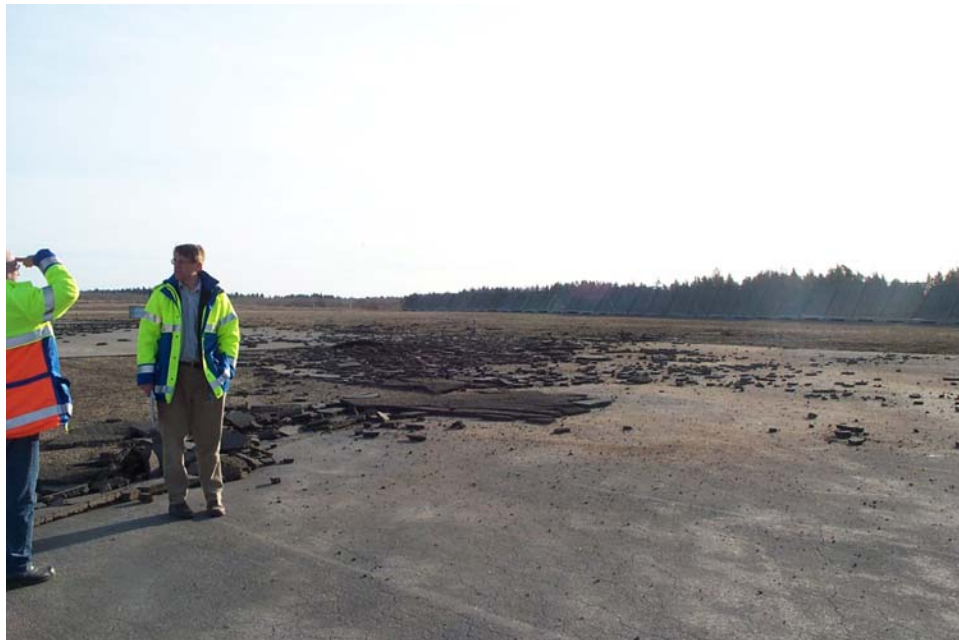
The tail (vertical and left horizontal stabilizer) of this 767 was heavily damaged as shown below, by pavement dislodged during a high-power engine run. The run-up was performed on a taxiway rather than on a dedicated run-up area. The debris field, shown below, was caused by the jet blast.
