## ***Boeing Guidance for Design of Run-up Areas***

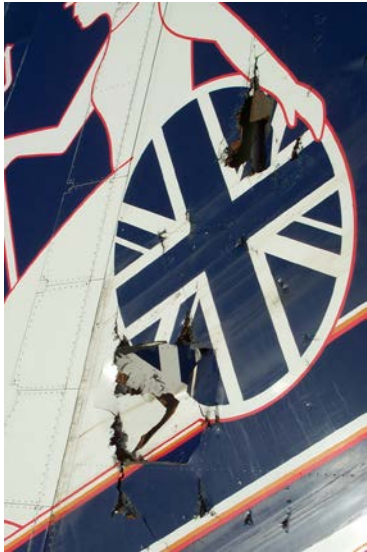
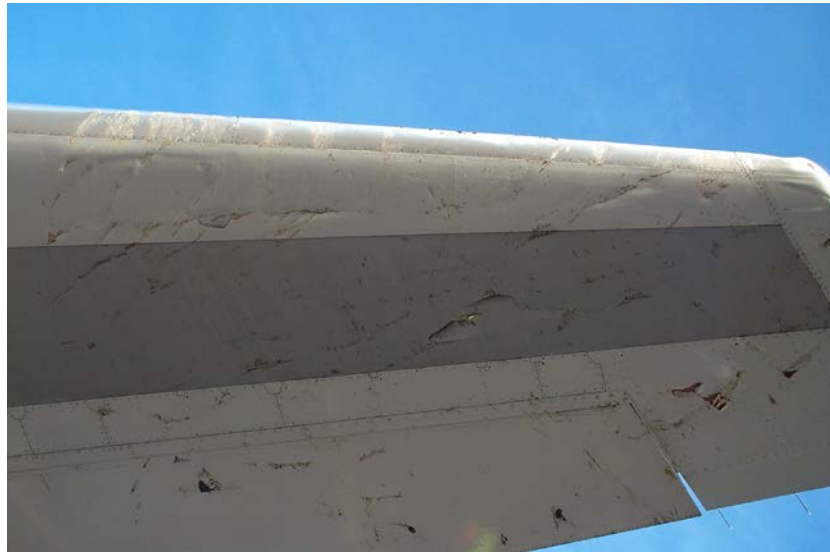
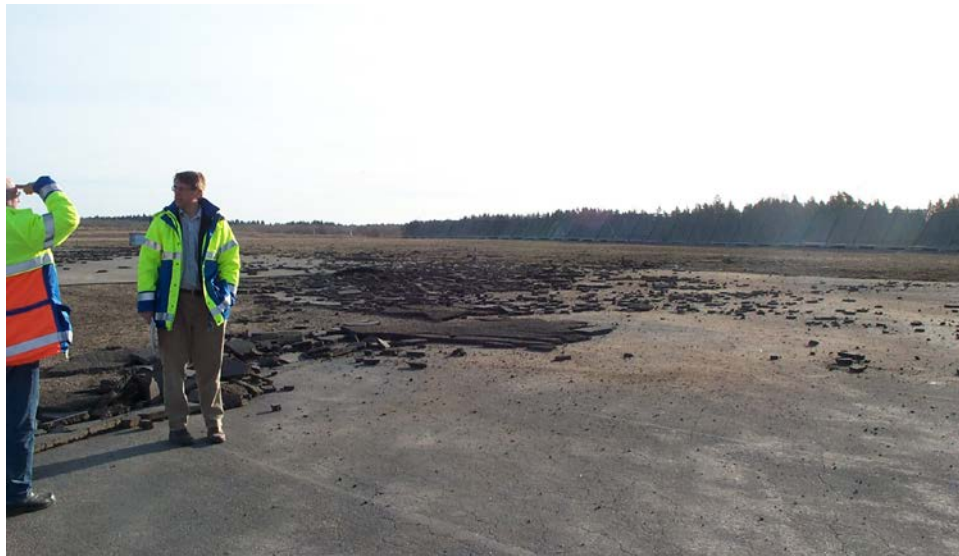
The tail (vertical and left horizontal stabilizer) of this 767 was heavily damaged as shown below, by pavement dislodged during a high-power engine run. The run-up was performed on a taxiway rather than on a dedicated run-up area. The debris field, shown below, was caused by the jet blast.

The preferred pavement surface on which to perform engine run-ups is concrete. However, often the area designated for run-ups is surfaced with asphaltic or bituminous materials. The surface ahead of and directly behind any location where an aircraft is likely to perform engine run-ups, or to have to initiate movement from a parked or standing position must be free of open cracks and have no unsealed feather edges. The asphalt surfacing should be 4 inches thick or greater (5 inches thick wherever widebody aircraft are operated) and should be firmly adhered to the underlying

pavement layers by way of a tack coat, or other means to assure a well bonded interface between the surface layer and the underlying strata.

Shoulder pavement in areas that are adjacent to aircraft support pavement should have thicknesses that are one inch less than those mentioned above but should have similar adhesion and must have smooth and well-sealed transitions to adjacent pavement areas.
